Figure 3. Best Environmental Practice Compliance

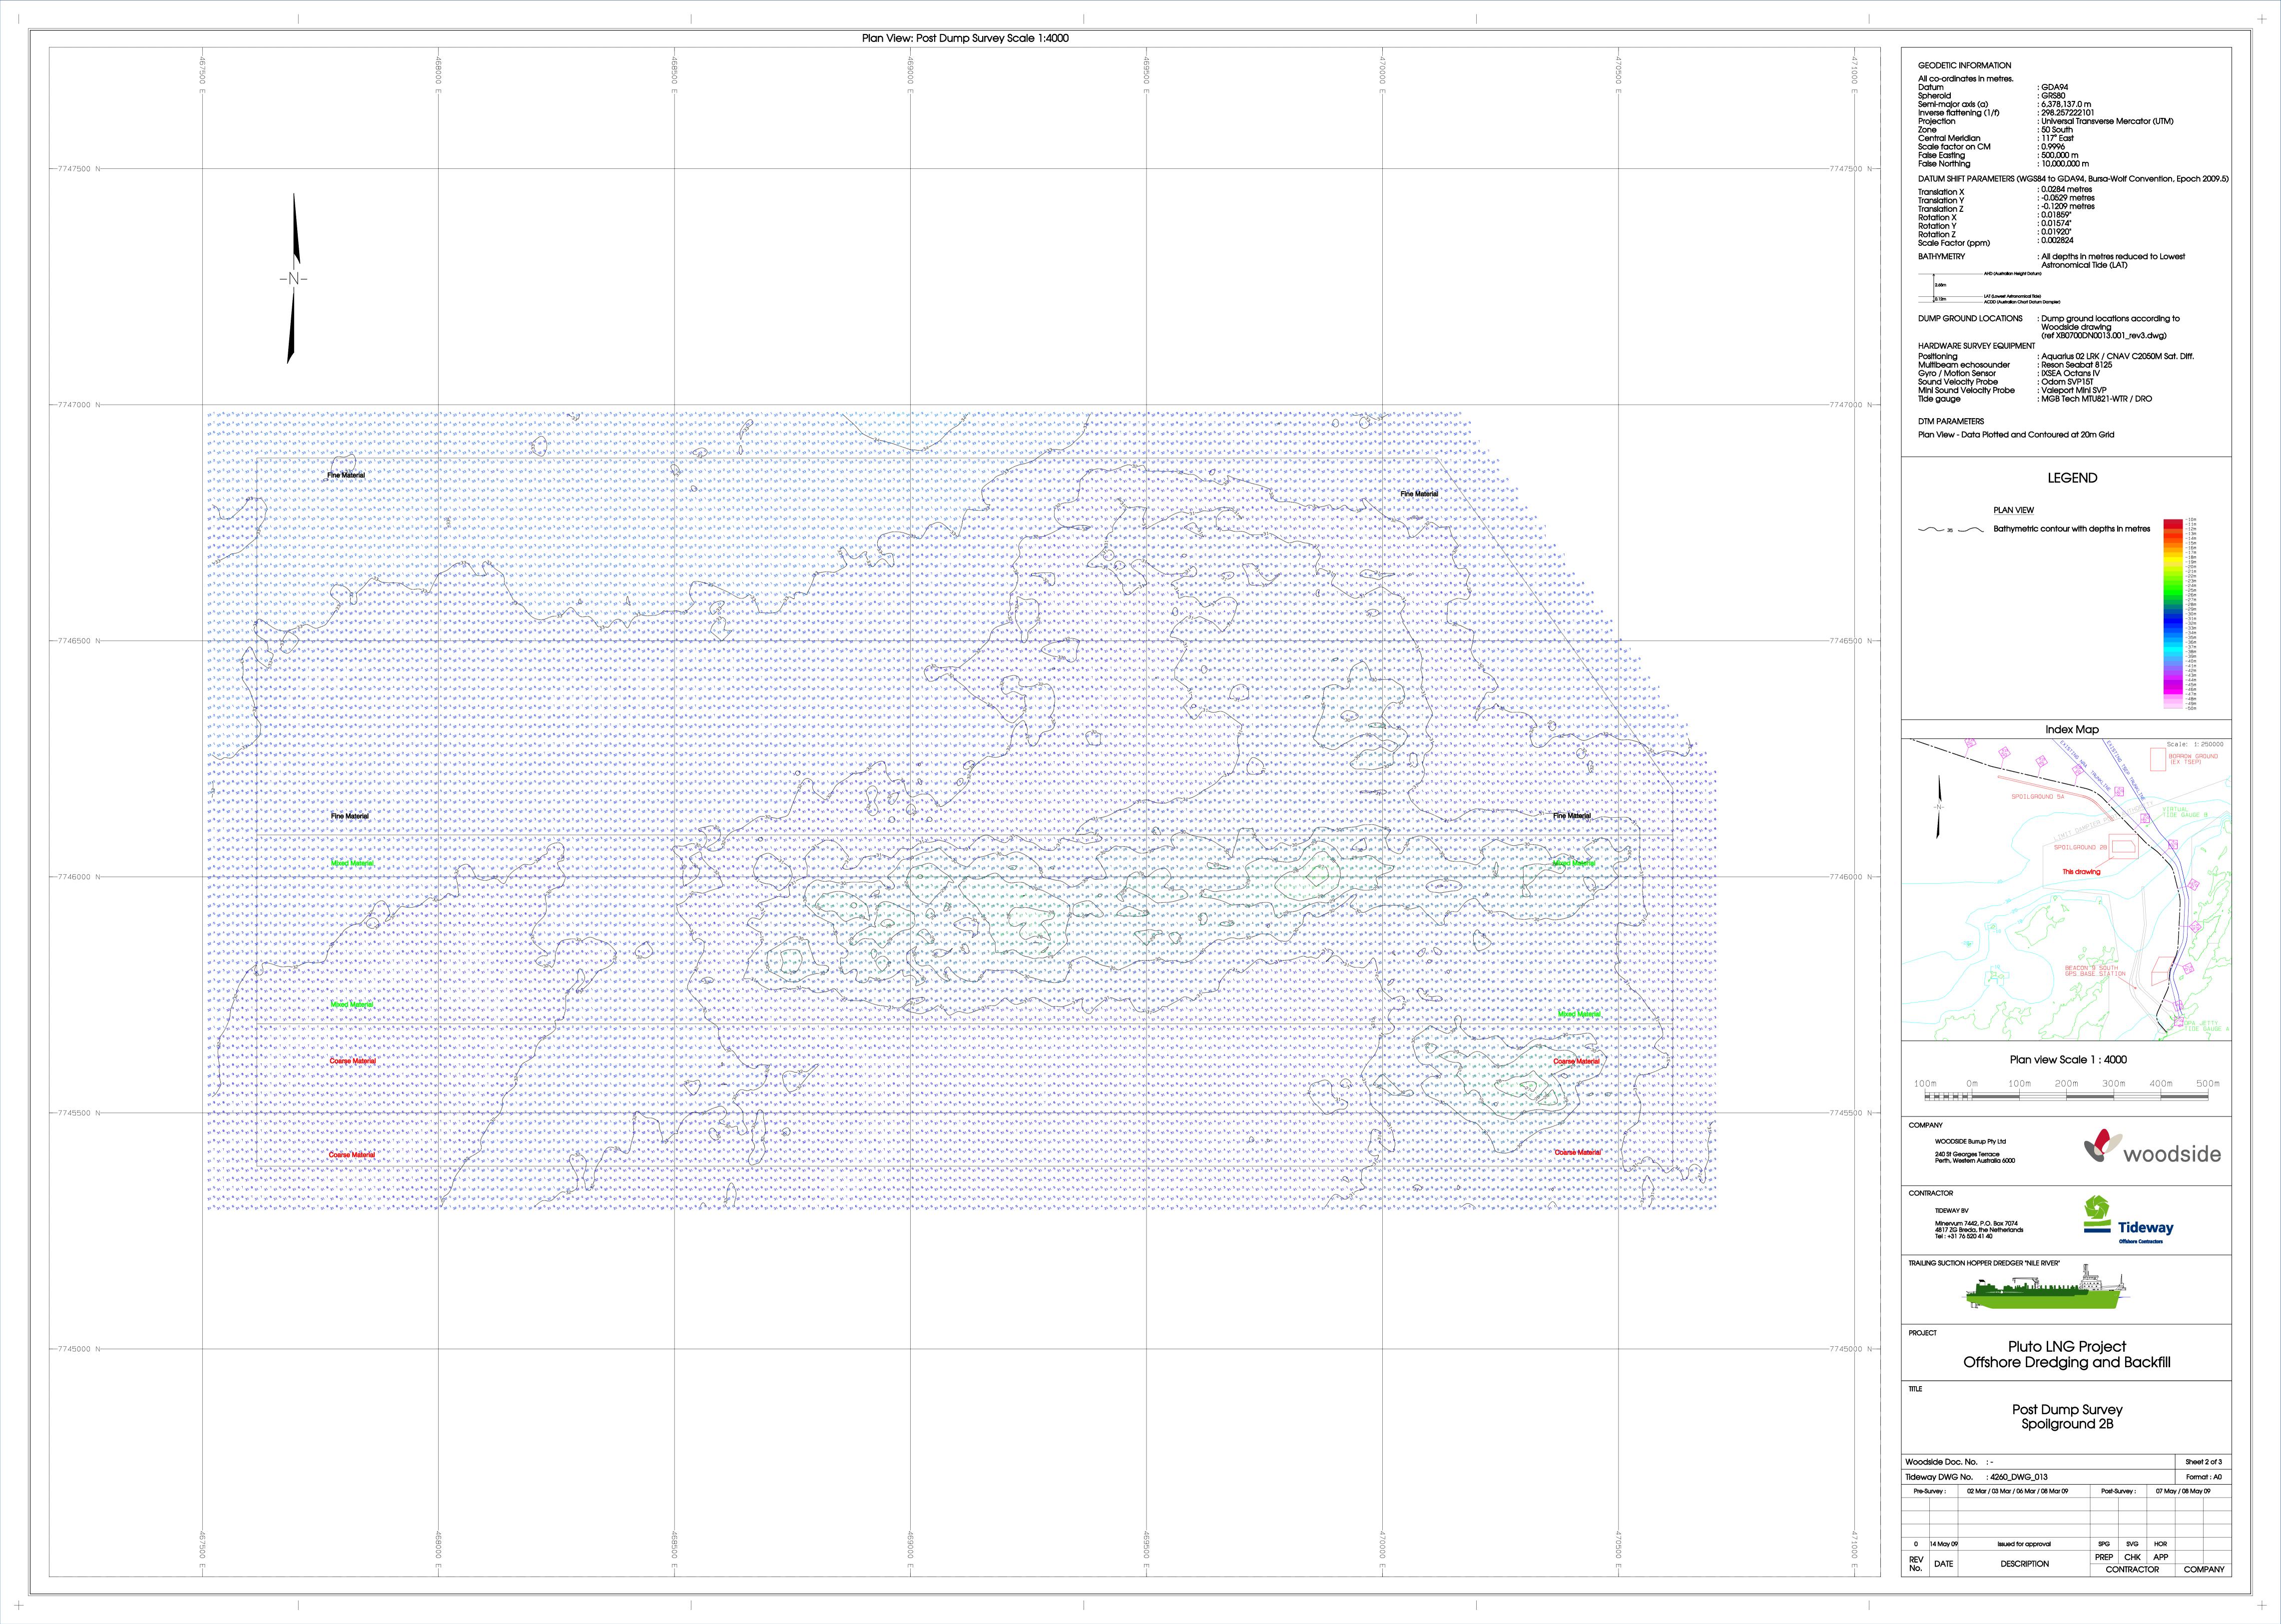
Description:
Bathymetric survey of Spoil Ground 2B at the completion of Phase 2 trunkline dredging works, 8
9 May 2009. Blue areas indicate 30 meters water depth, while green areas indicate shallower regions of 27 meters water depth.

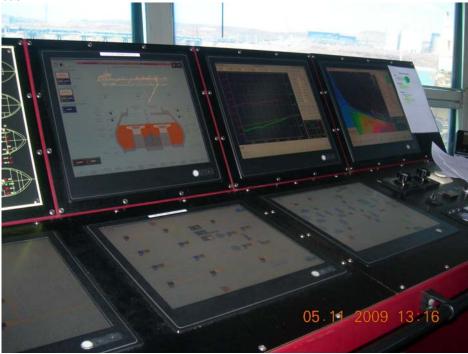
Figure 4. Best Environmental Practice Compliance

Description:
Operational equipment onboard TSDS 'Queen of the Netherlands' during operation in the turning basin.

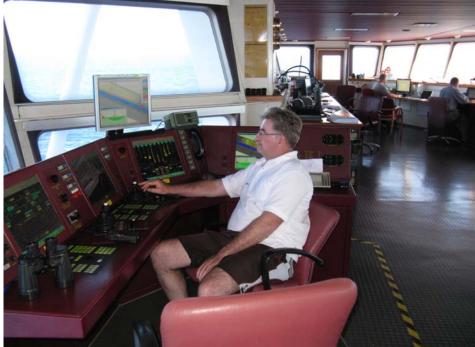
Figure 5. Best Environmental Practice Compliance

Operational equipment onboard the TSDS 'Nile River' during operations along the trunkline.

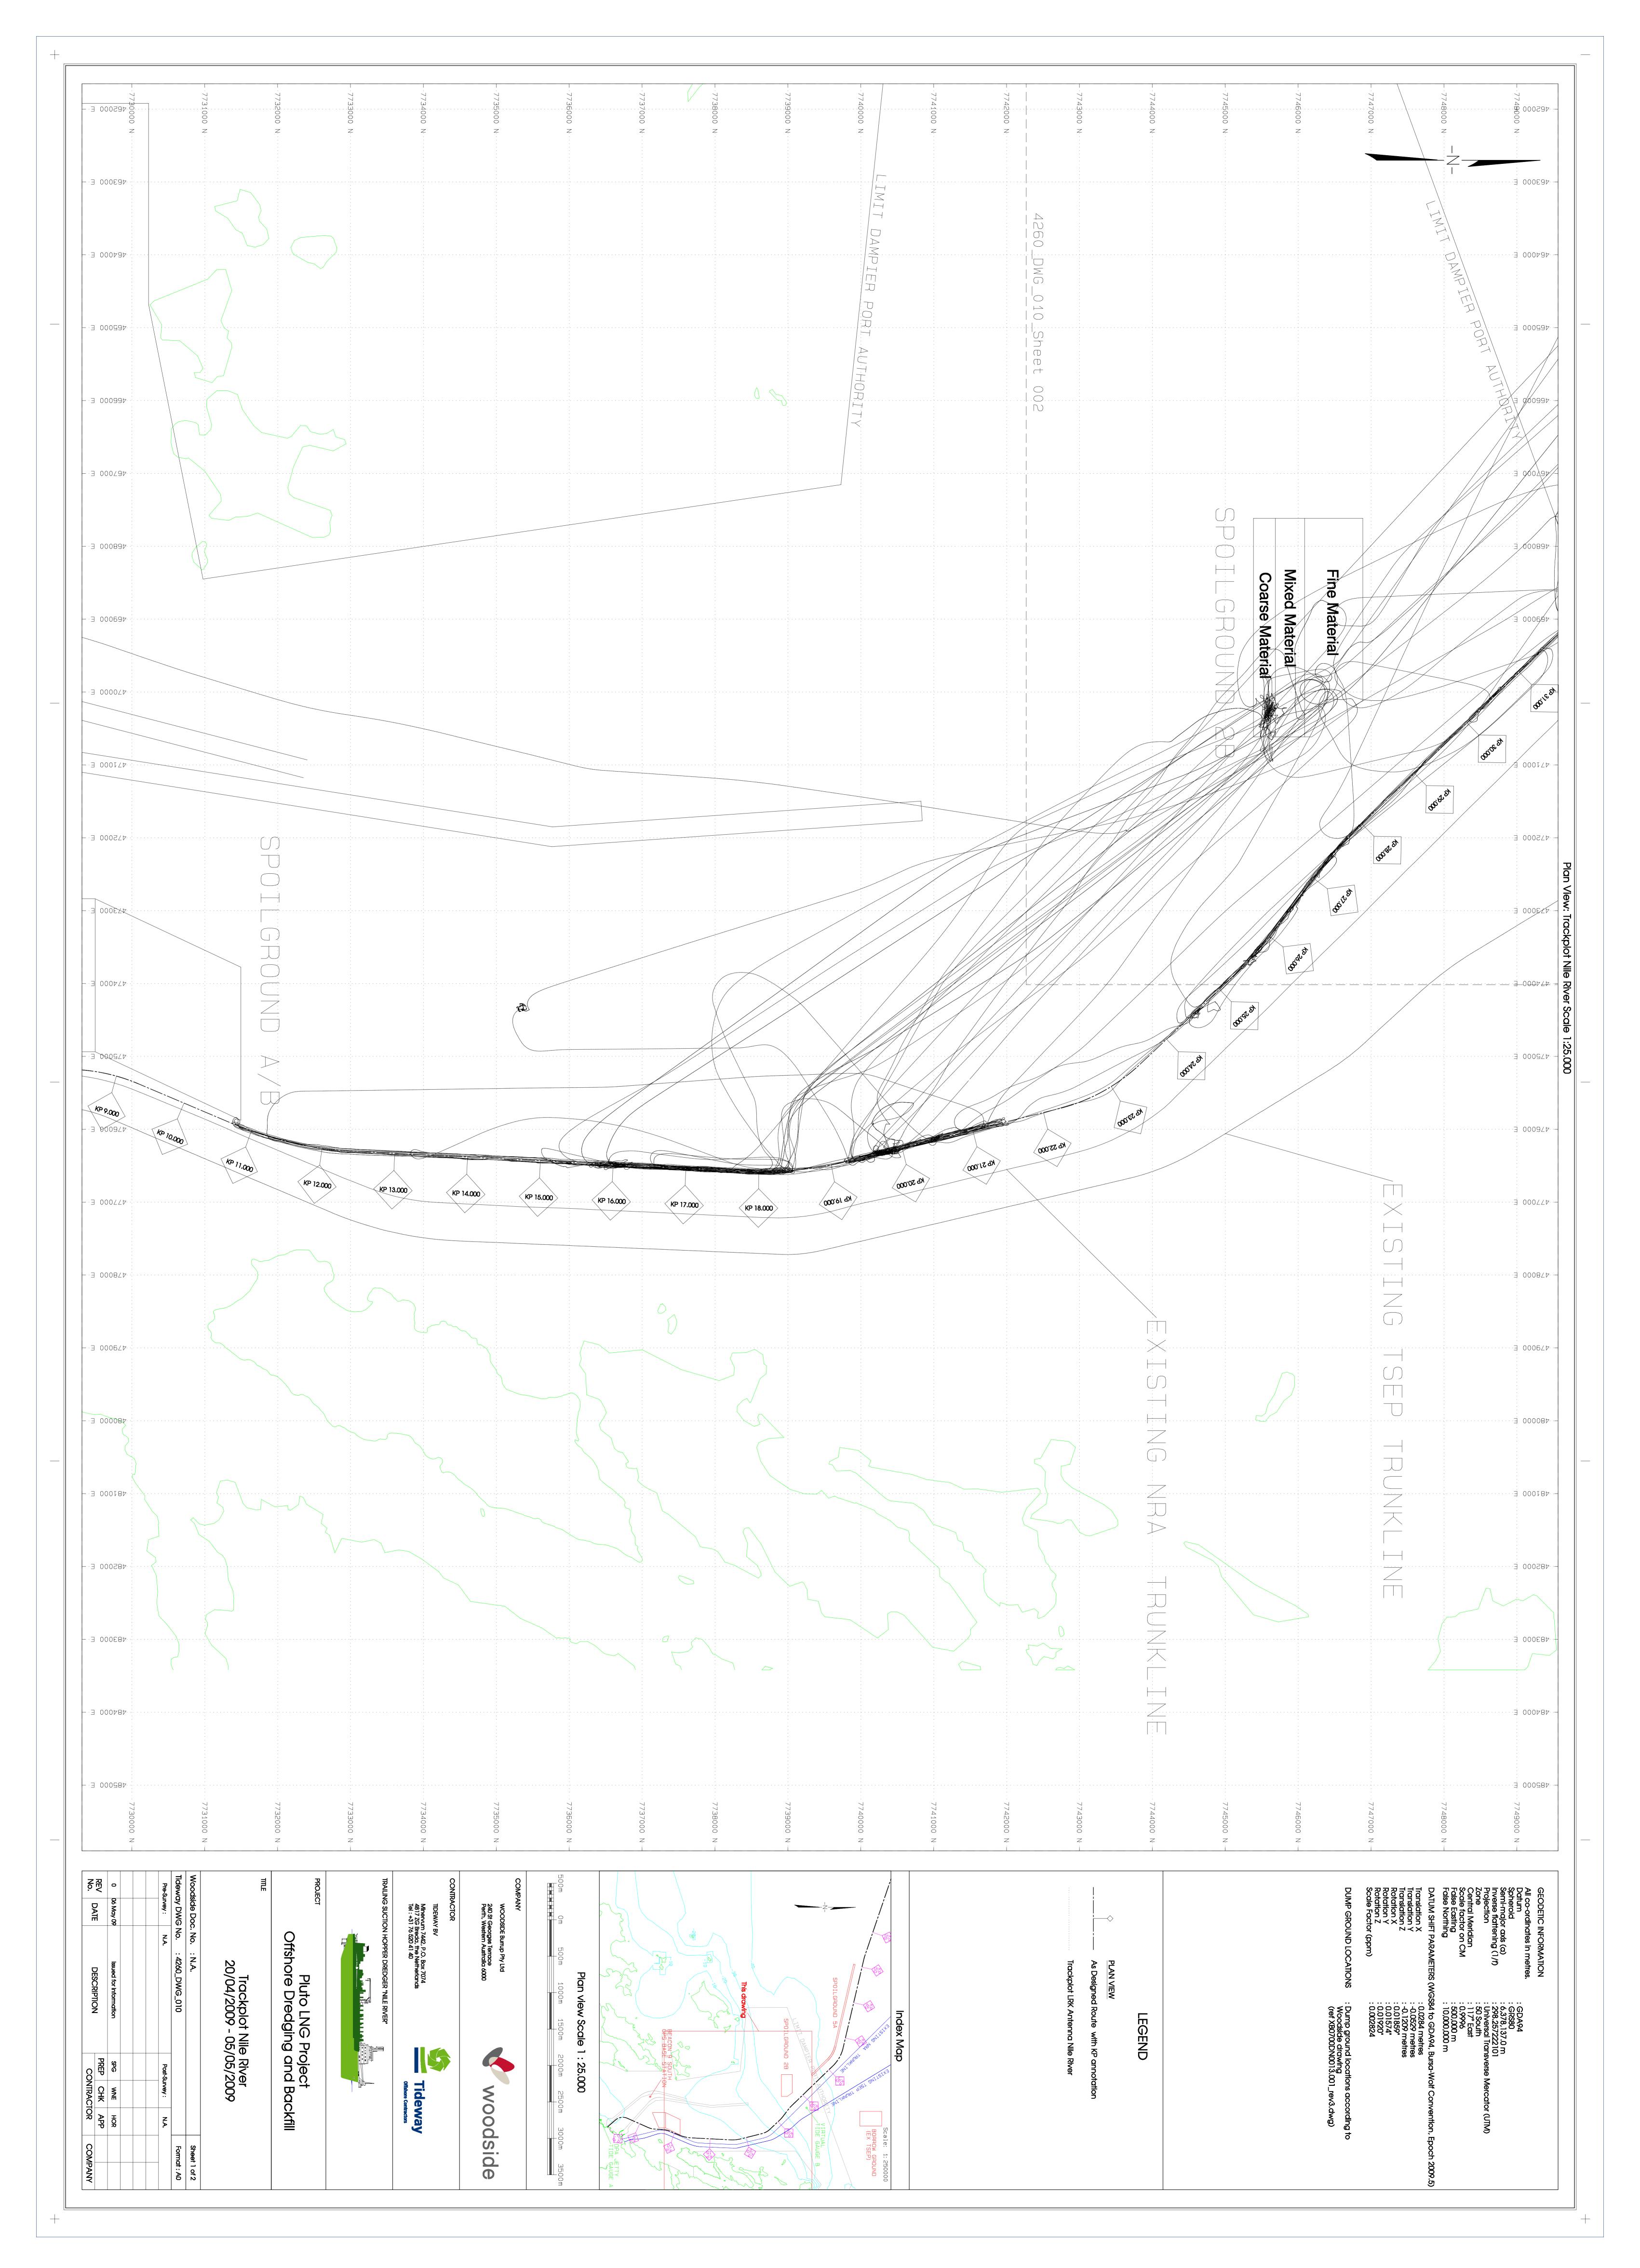
Figure 6. Best Environmental Practice Compliance

Weekly track plot for the TSHD 'Nile River' from 20 April – 5 May 2009. The areas of concentrated activity along the Pluto LNG Project trunkline between KP11 – KP31 represent the locations where dredging was occurring (i.e. repeated passes over a location). The Nile River dumped material at Spoil Ground 2B over this period. The track lines on this figure are plotted using DGPS (Differential Global Positioning System) data extracted directly from the ship's log, which records continuously, therefore transit routes are also plotted.

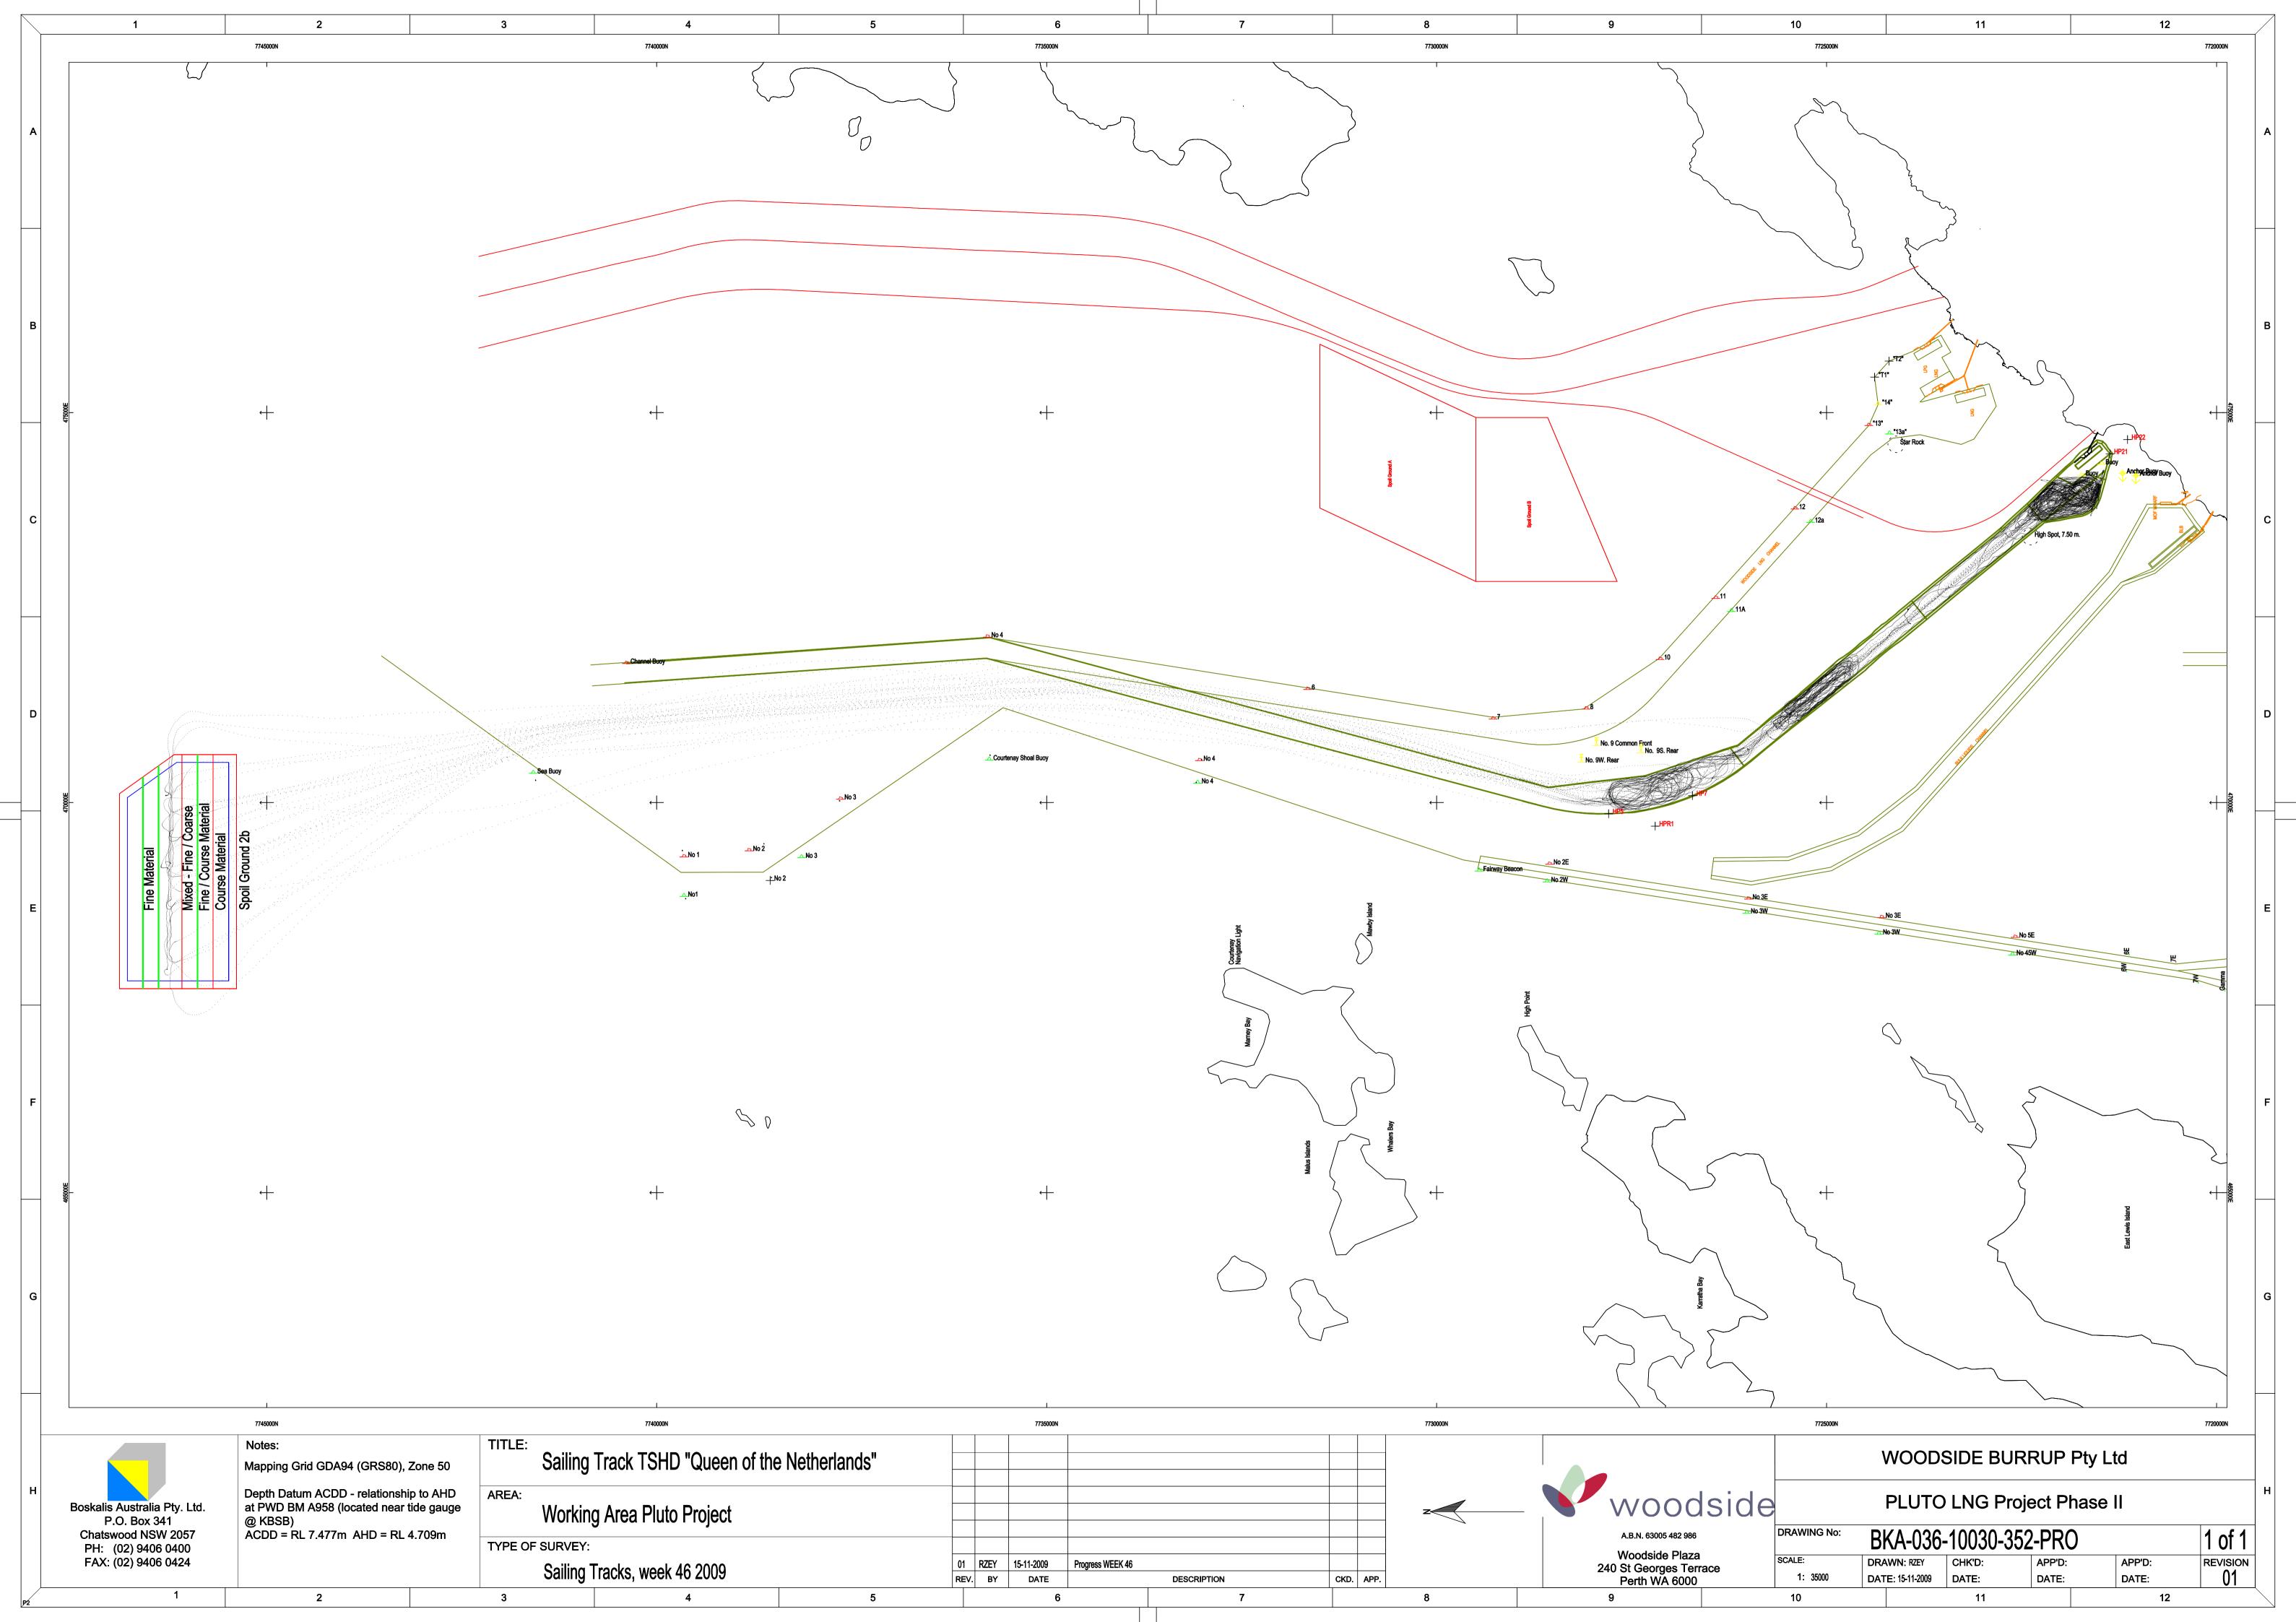
Figure 7. Best Environmental Practice Compliance

Weekly track plot for the TSHD 'Queen of the Netherlands' from Week 46, 2009. The Areas of concentrated activity within the turning basin represent the locations where dredging was occurring (i.e. repeated passes over a location). Material was dumped at Spoil Ground 2B over this period. The track lines on this figure are plotted using DGPS (Differential Global Positioning System) data extracted directly from the ships log, which records continuously, therefore transit routes are also plotted.

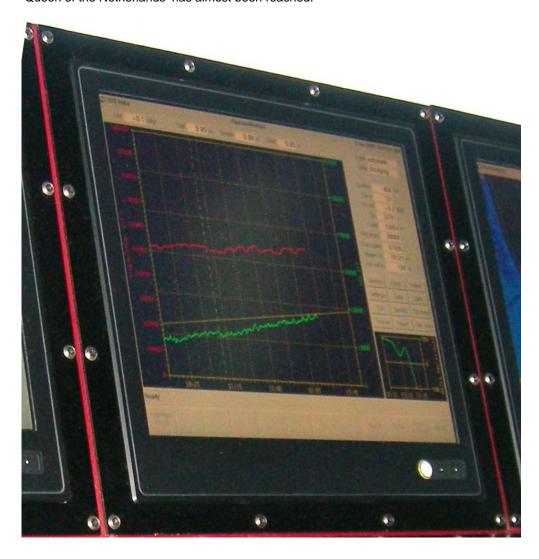
Figure 10. Best Environmental Practice Compliance

Real-time dredge management system with loading chart displayed. The solid yellow line indicates the optimal load point where additional overflow time will not result in significantly improved load size. This photograph demonstrates that the optimal loading point onboard the 'Queen of the Netherlands' has almost been reached.

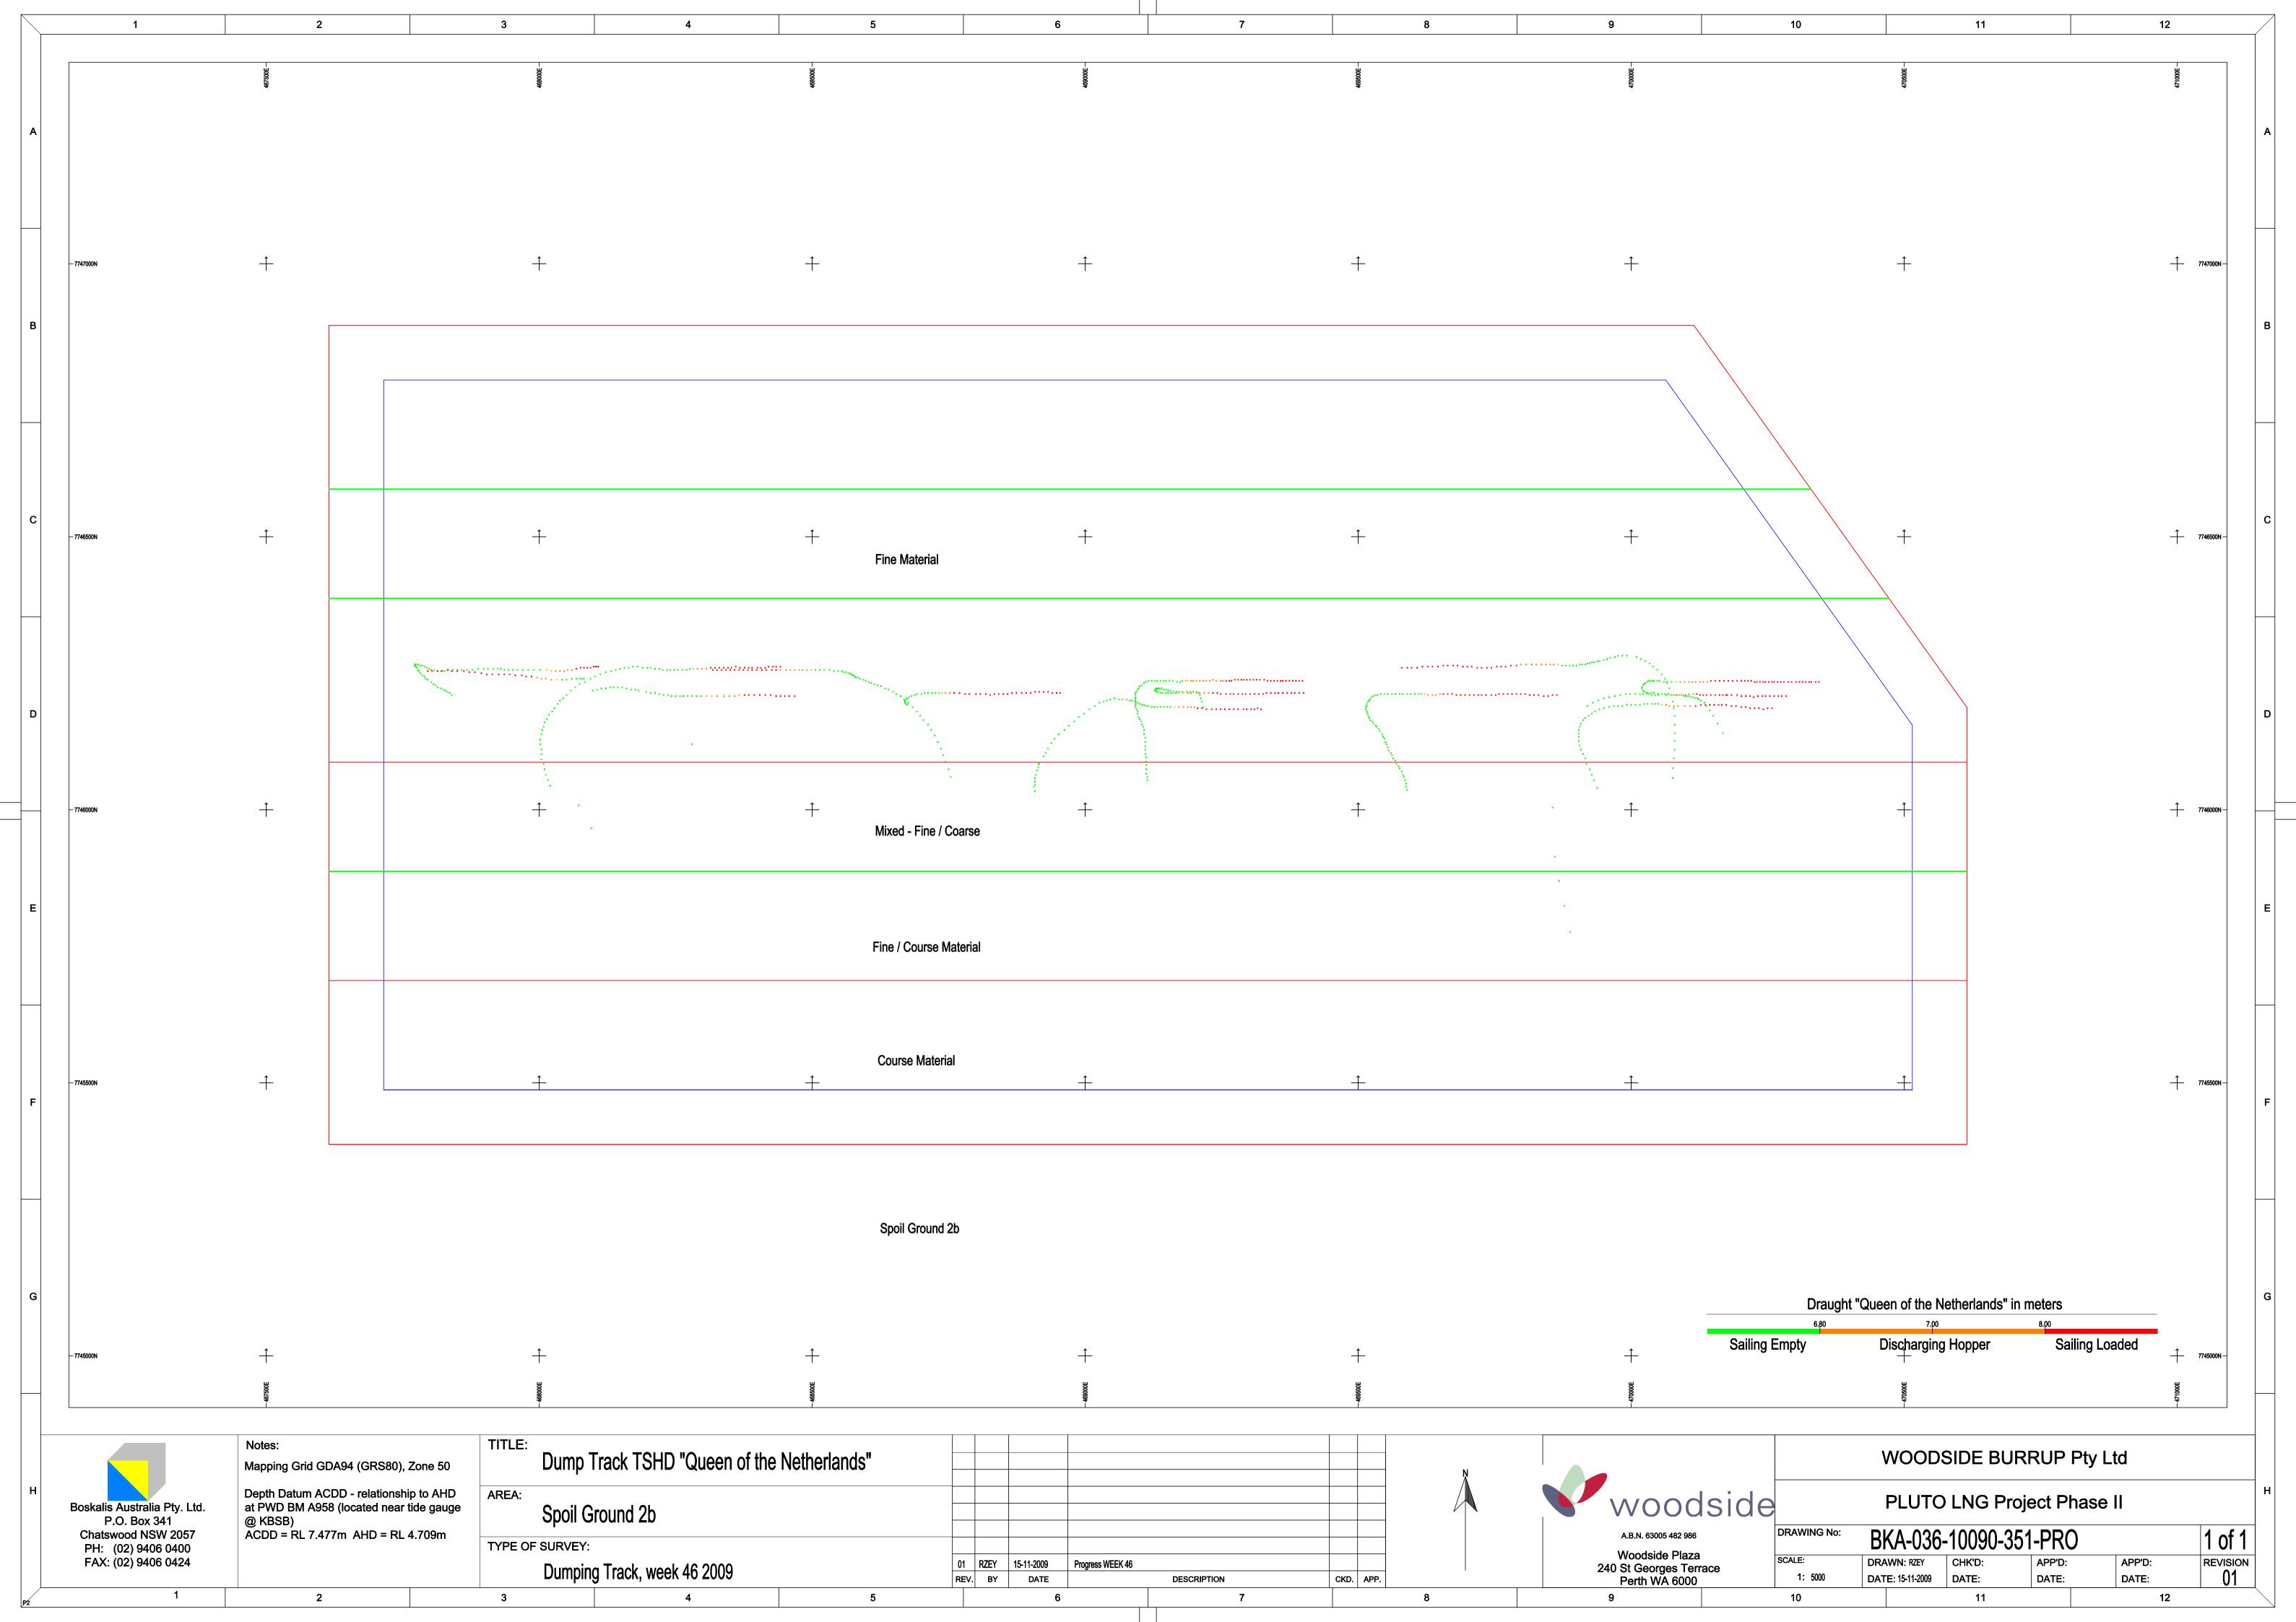
Figure 11. Best Environmental Practice Compliance

Description:
Weekly dump plot showing the location of individual dump passes on Spoil Ground 2B by the Queen of the Netherlands. Individual loads are dumped within the spoil ground boundary and into separate sections dependent on the nature of the material dredged.
