Pluto LNG – Sea Turtle Management Plan

December 2025

Revision 14

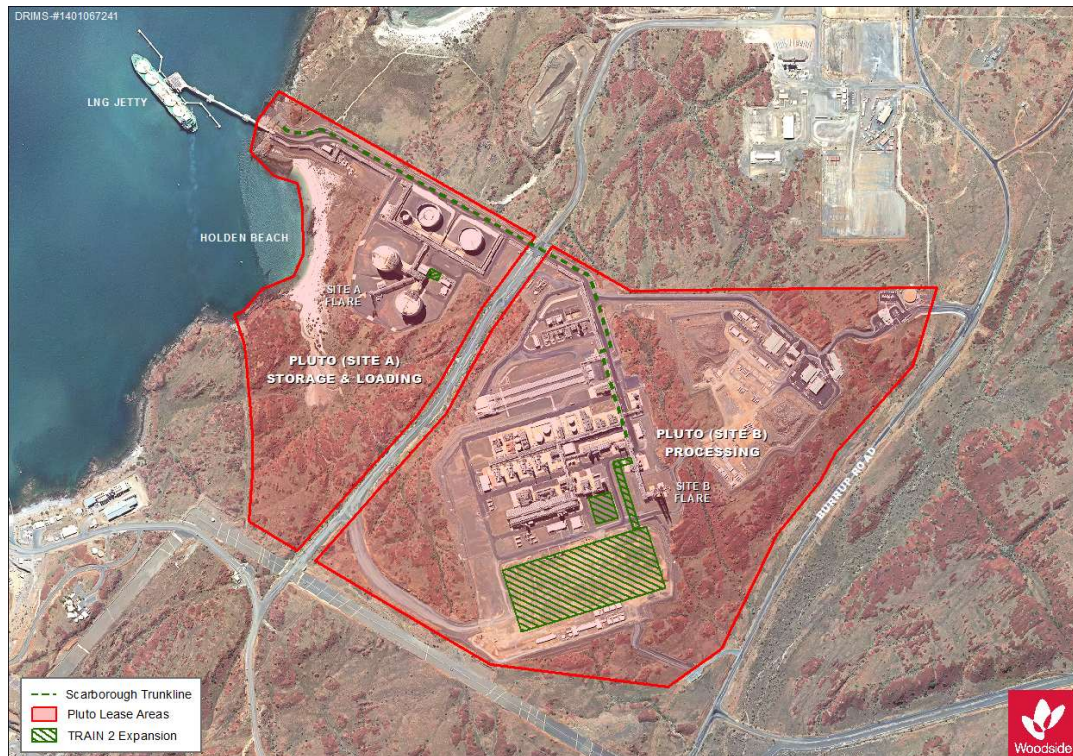
Figure 1 - Pluto LNG Site A and B on the Burrup Peninsula

The onshore and nearshore components of Pluto Foundation and the approved Pluto Expansion are shown within **Figure 1**.

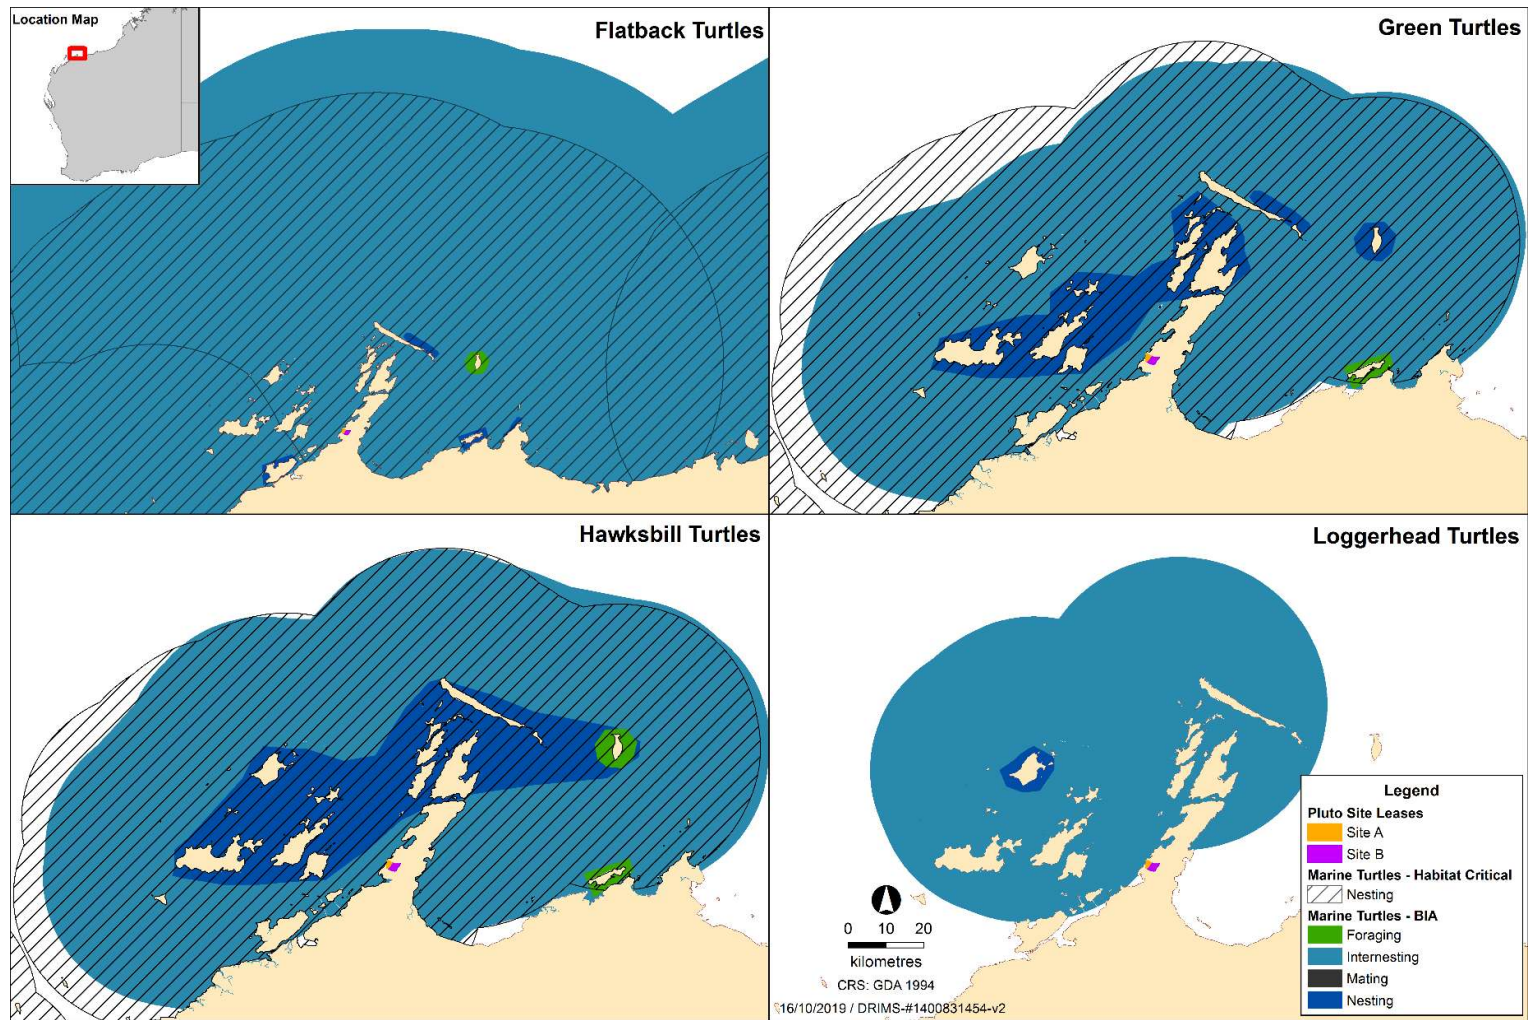
Figure 2 – Habitat Critical and BIAs for Sea Turtle Species within the Dampier Archipelago (DoEE, 2017)

Post-nesting migratory routes for green, hawksbill and flatback turtles were recorded for the Northwest Marine Region (from Barrow Island and mainland sites) (Chevron Australia Pty Ltd, 2015). Green, flatback and hawksbill turtles travelling from nesting sites to foraging grounds generally travelled east or south of Barrow Island and around or through the Dampier Archipelago and along the coast towards foraging grounds to the north (north of Broome). The hawksbill turtle was an exception as it tended to travel south to the coastal island chain south of Barrow Island (Chevron Australia Pty Ltd, 2015). As shown in **Figure 2**, there is a defined foraging BIA for green and hawksbill turtles around Dixon Island.

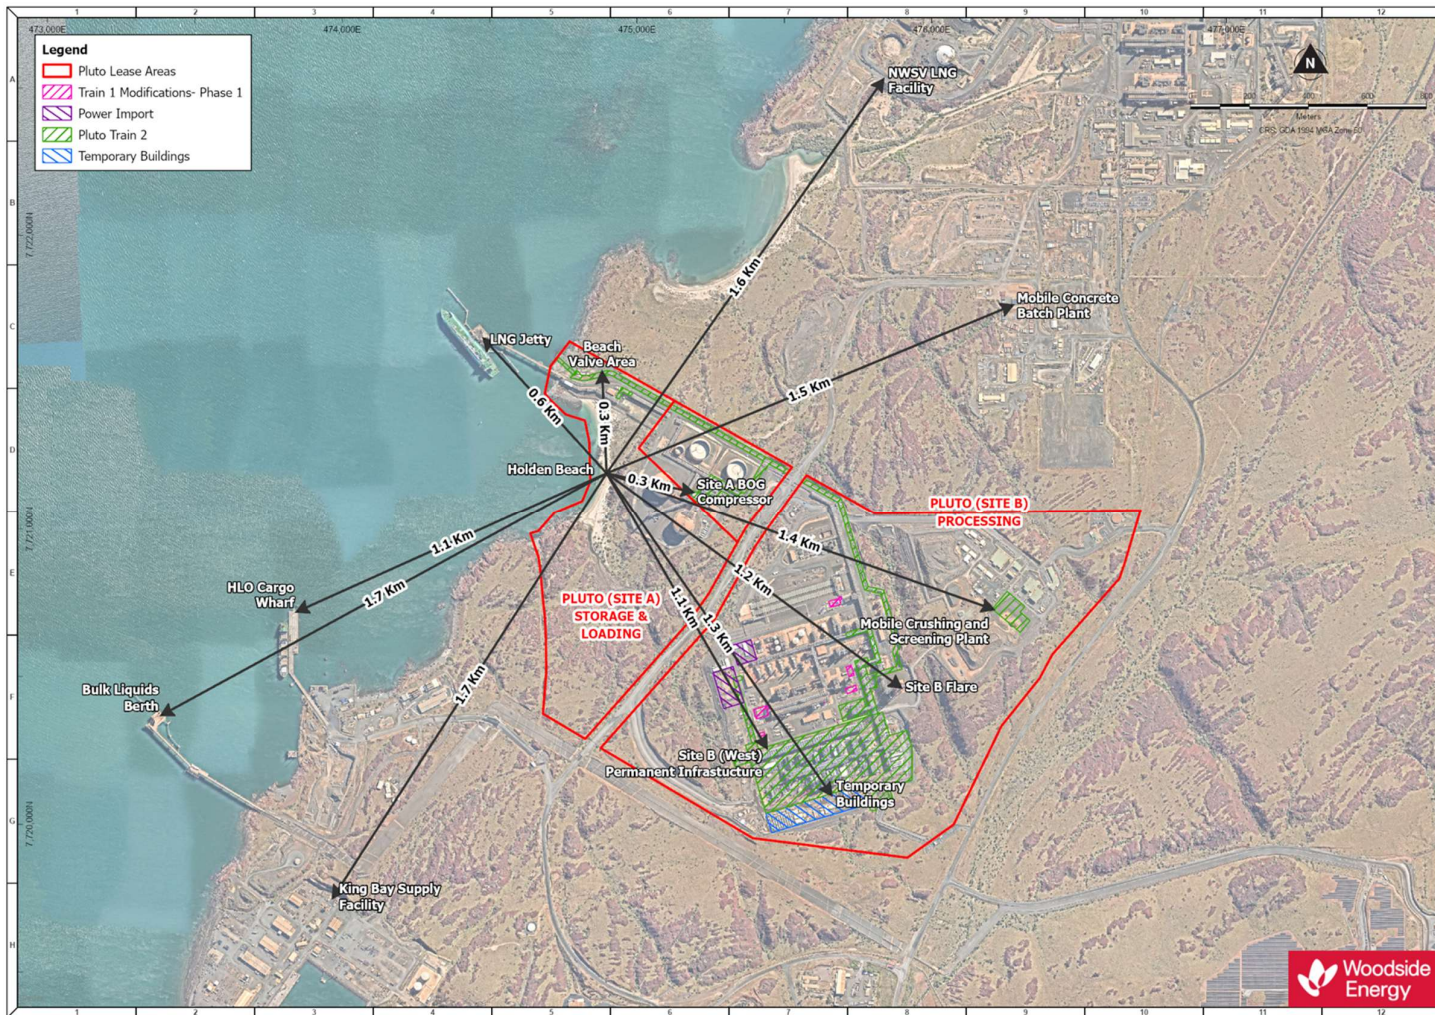
Figure 4 - Existing and proposed lighting sources in proximity to Holden Beach

Infrastructure	Distance/ Direction from Holden Beach	Lighting observed from Holden Beach
Pluto LNG Jetty	Adjacent to Holden Beach	Direct line of sight
Pluto LNG Storage and Loading Flare (Site A)	0.21 km east	Direct line of sight
Pluto LNG Site A infrastructure	Adjacent to Holden Beach	Light overspill/glow
Pluto LNG Flare stack (Site B)	1.18 km east	Light overspill/glow
Dampier Cargo Wharf	1.1 km south	Direct line of sight
Bulk Liquids Berth	1.7 km south	Direct line of sight
NWSV LNG Facility	1.6 km north	Direct line of sight
Dampier Port Authority- Cargo Wharf Administration Building	1 km south	Light overspill/glow
King Bay Supply Base	1.8 km south	Light overspill/glow
LNG Tankers/ Vessels (Transient)	Not applicable	Light overspill/glow

The Pluto Light Management Plan (LMP) is provided within Appendix B. The focus of the LMP is on the mitigation of installed lighting at Pluto LNG, with a focus on the management of defined zones. The Pluto LNG Storage and Loading flare (Site A), while nearby, is not the focus of the LMP. To further reduce the risk of impact from the storage and loading flare, loading activities would need to be scheduled for daylight only hours. The significant costs of instituting this measure are grossly disproportionate to the benefit gained in risk reduction. This would increase the risk of “tank tops” events, during which LNG and/or condensate tanks would reach maximum safe levels, and production would become constrained. The monitoring results gathered over time have not shown that flaring has had a significant impact on sea turtles (Section 2.2). This indicates that the benefit, being reduced likelihood of marine turtle disorientation, is disproportionate with the potential production impacts.

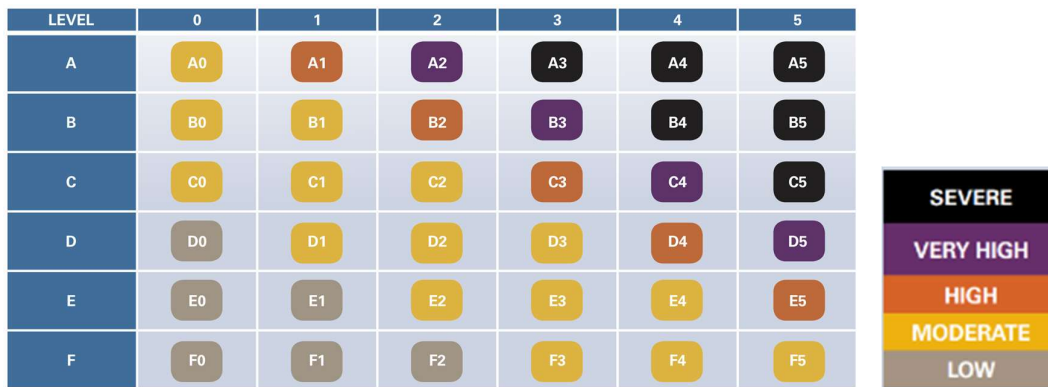
Figure 5 Woodside risk matrix – risk level

The criteria that have been applied to determine ‘likelihood’ and ‘consequence’ of each potential impact/project activity are presented within Appendix A. The risk level is derived from the consequence and likelihood levels determined above in accordance with the risk matrix are shown in **Figure 5**.

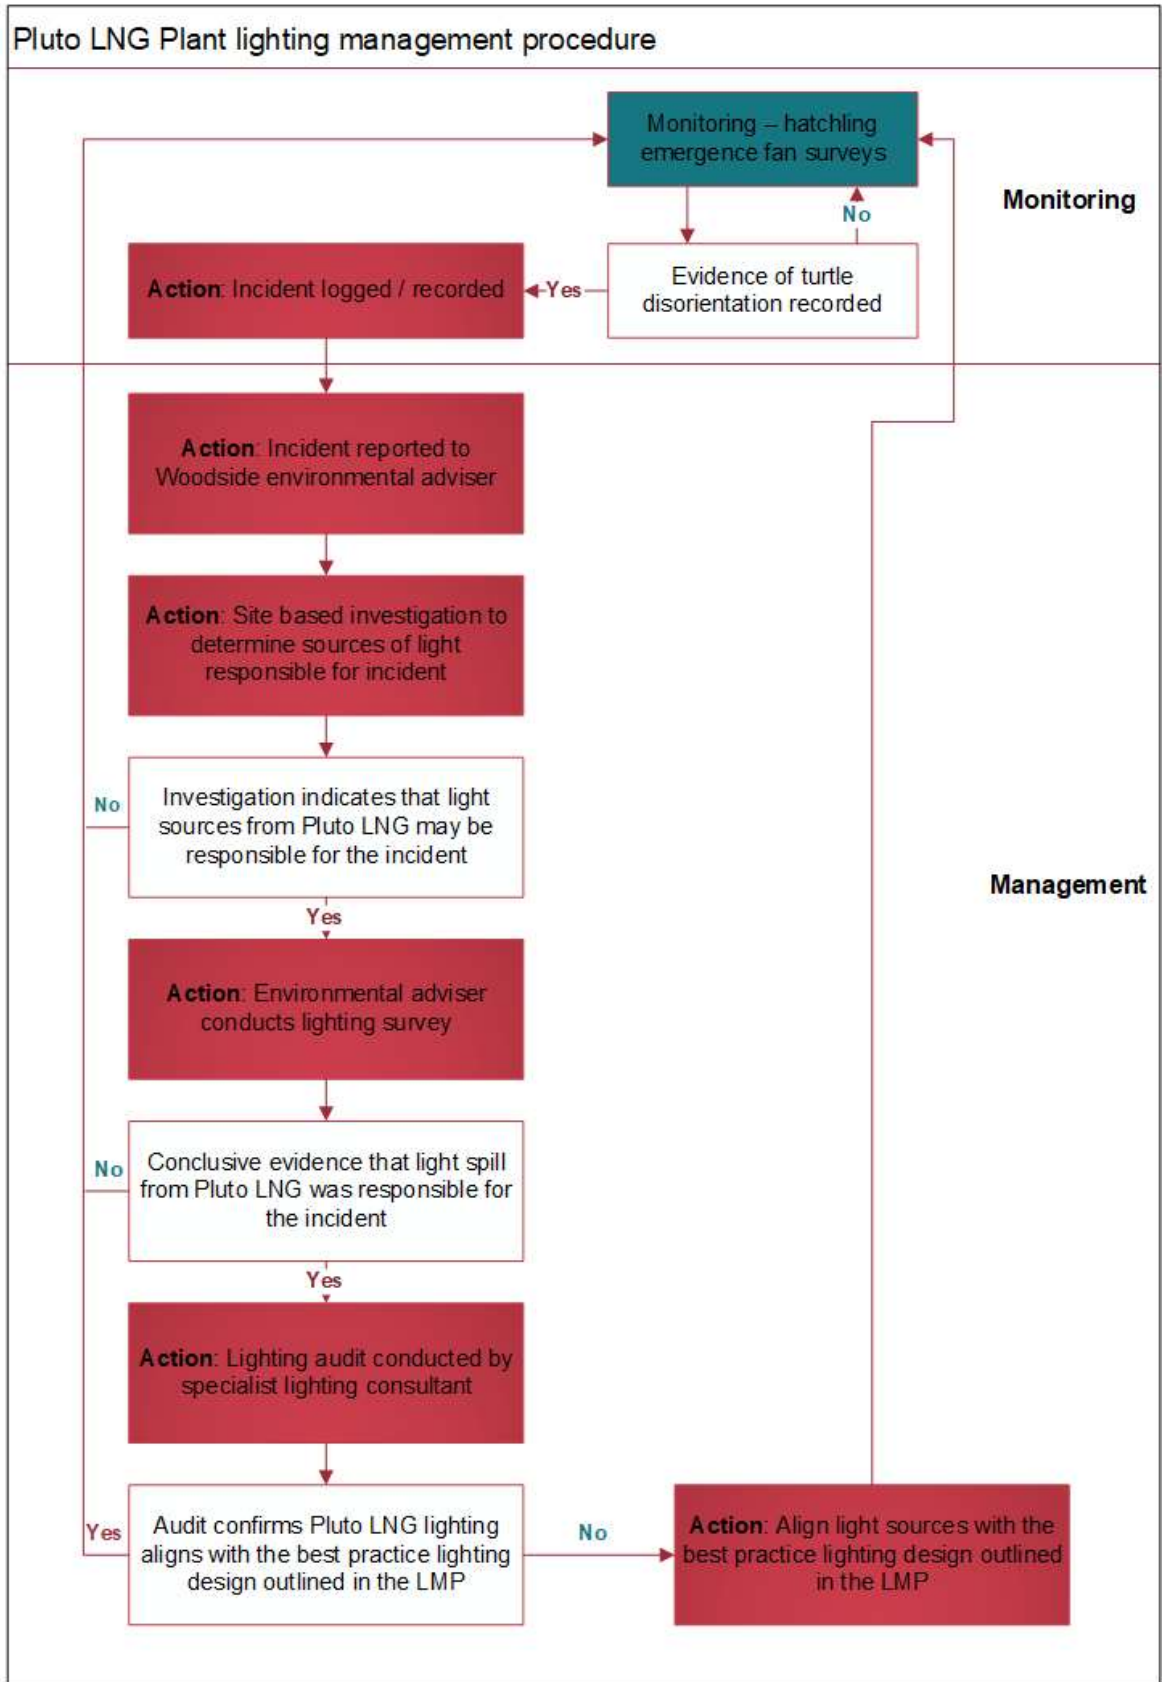
Figure 6 – Pluto LNG lighting management procedure

Table 13 and **Table 14** summarise the subsequent actions that will be implemented if evidence of turtle disorientation resulting from onshore lighting from Pluto LNG (Foundation or Expansion) is recorded. The adaptive management framework that would apply for both operational and construction phases of the project is shown in **Figure 6**.

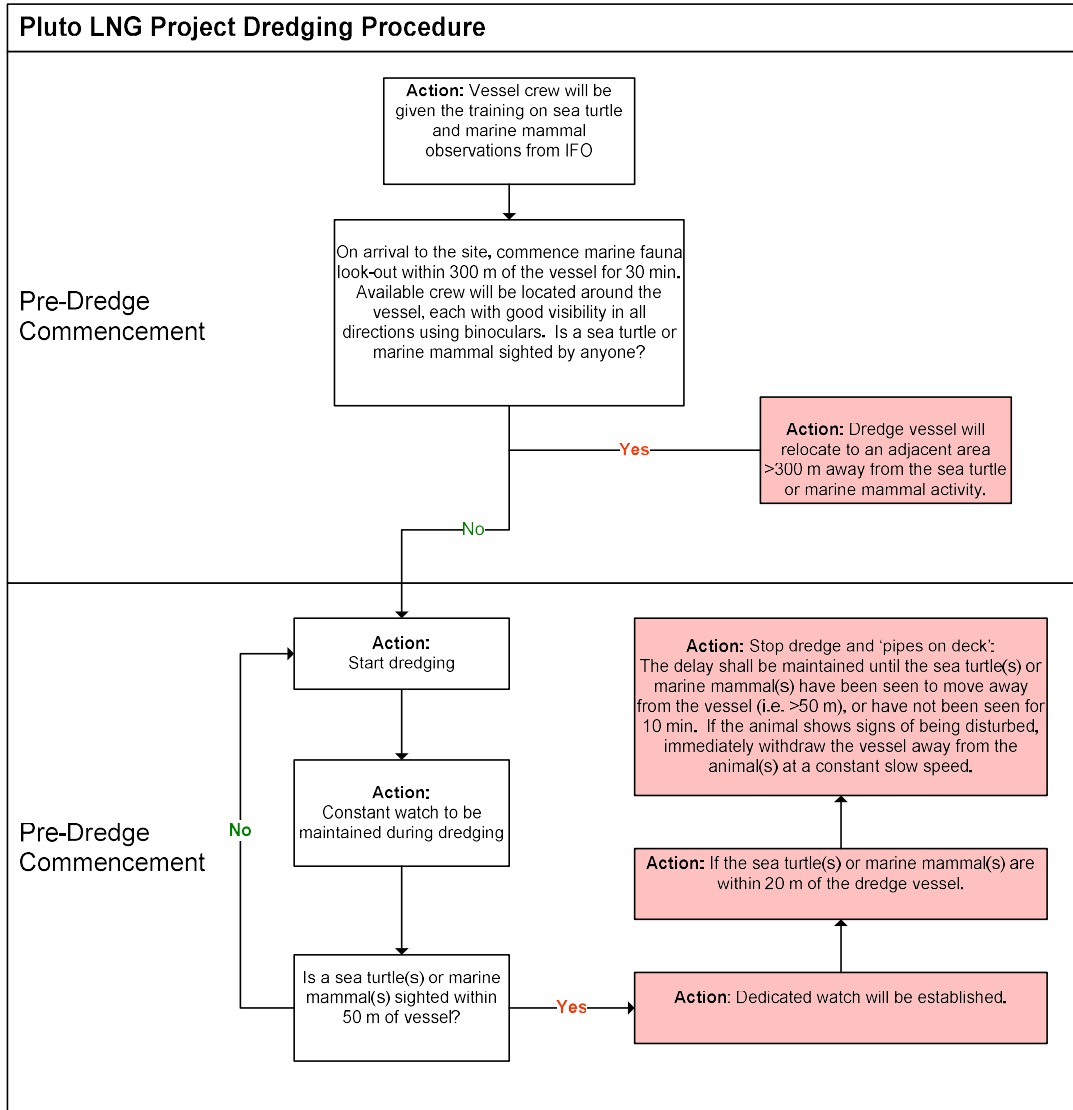
Figure 7 - Maintenance Dredging Procedure

In advance of future maintenance dredging activities (related to Pluto Foundation), the dredge vessel crew will receive training from a qualified marine fauna observer (MFO). In the absence of a MFO, the vessel captain will be responsible for logging sighting and sea turtle injury/death reporting by the crew. These procedures must be followed as part of any maintenance dredging (**Figure 7**) and spoil disposal (**Figure 8**) procedure.

It is noted that the dredging procedure (**Figure 7**) identifies a 20 m exclusion zone to be maintained for sea turtles and marine mammals in the event that animals are identified within 50 m of the vessel. Application of the 20 m exclusion zone with respect to dolphins is not considered feasible. Dolphins are unique in that they:

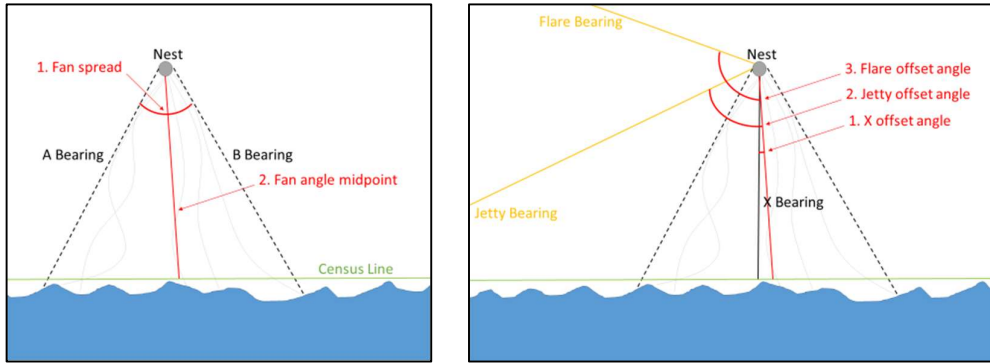
Figure 9 - Illustration of fan spread and offset angle parameters for hatchling emergence fan survey

This data is used to calculate the following:

- Fan spread, which is the angle between A-B Bearings.
- Fan angle midpoint, which is the midpoint between A-B Bearings.
- Offset Angles, which are the angles between the fan angle midpoint and
 1. the X Bearing (X offset angle);
 2. the Jetty Bearing (Jetty offset angle); and
 3. the Flare Bearing (Flare offset angle).

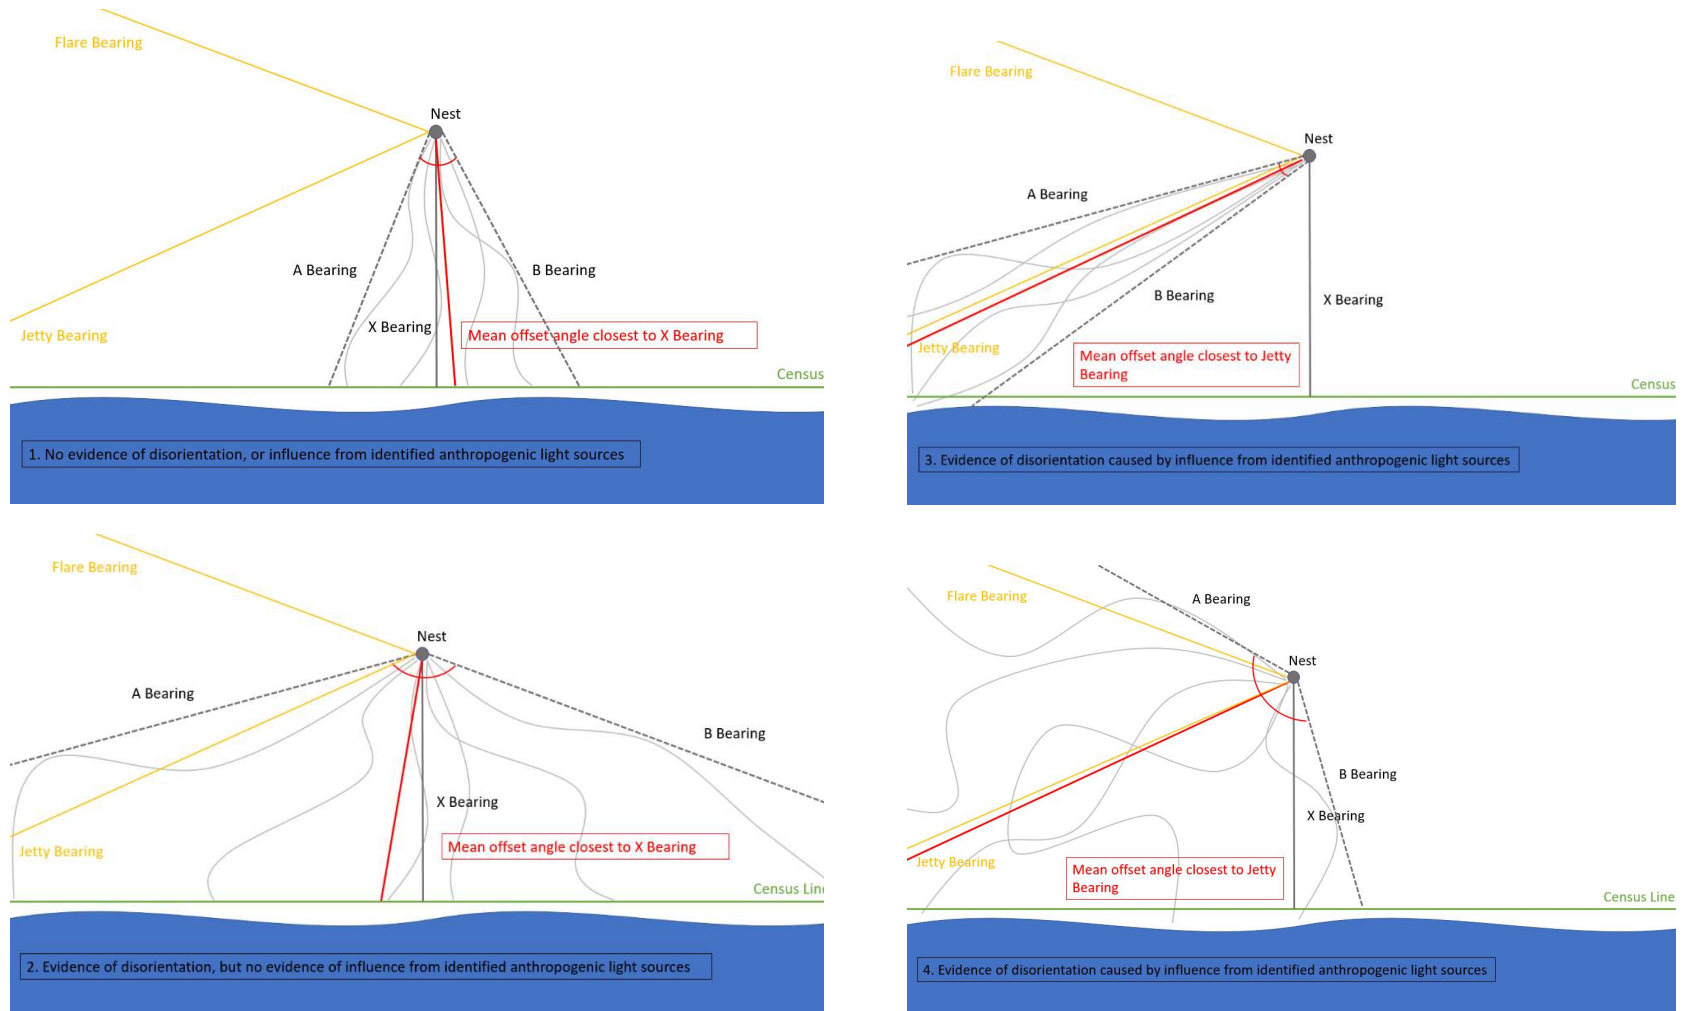
To determine hatchling orientation, the smallest offset angle can be used to infer the most influential navigation aid used by the hatchlings. If the smallest angle is the X offset angle then it can be concluded that there was no significant influence from the identified anthropogenic light sources (as shown in **Figure 10(1)** and **10(2)**). Alternatively, if the smallest angle is either the jetty or the flare offset angles, there is evidence that these light sources are significantly influencing the hatchling’s navigation (as shown in **Figure 10(3)** and **10(4)**).

Figure 10 outlines the main scenarios that may occur from the described hatchling emergence fan surveys: the top-left illustrates a scenario where there is no evidence of disorientation or influence from anthropogenic sources; the bottom-left figure illustrates evidence or disorientation, however, with no apparent influence from the identified anthropogenic light sources; the top and bottom figures on the right show influence from the jetty anthropogenic light source, with both small and large fan spread angles. In both these cases, it would be considered that there was an incident or hatchling turtles being disoriented by light associated with Pluto LNG and proceeding actions would be triggered (refer to Performance Management Targets in **Table 13** and **Table 14**).

Figure 10 - Hatchling emergence fan survey decision criteria (top-left: no disorientation or anthropogenic influence; bottom-left: evidence of disorientation, but no anthropogenic influence; top and bottom right: evidence of disorientation caused by anthropogenic influence).

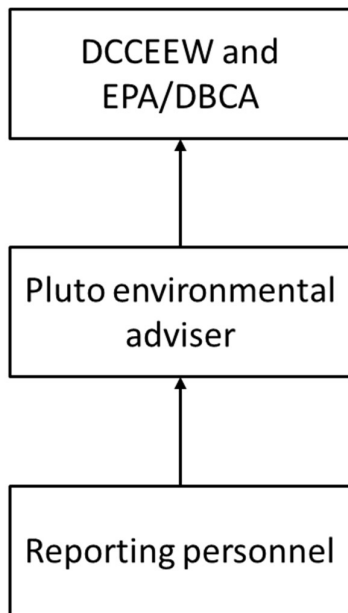
Figure 11 - Recommended Reporting Line of turtle incidents/observations for Pluto LNG Operations

Figure 11 shows the reporting structure for turtle incidents and observations during operations.

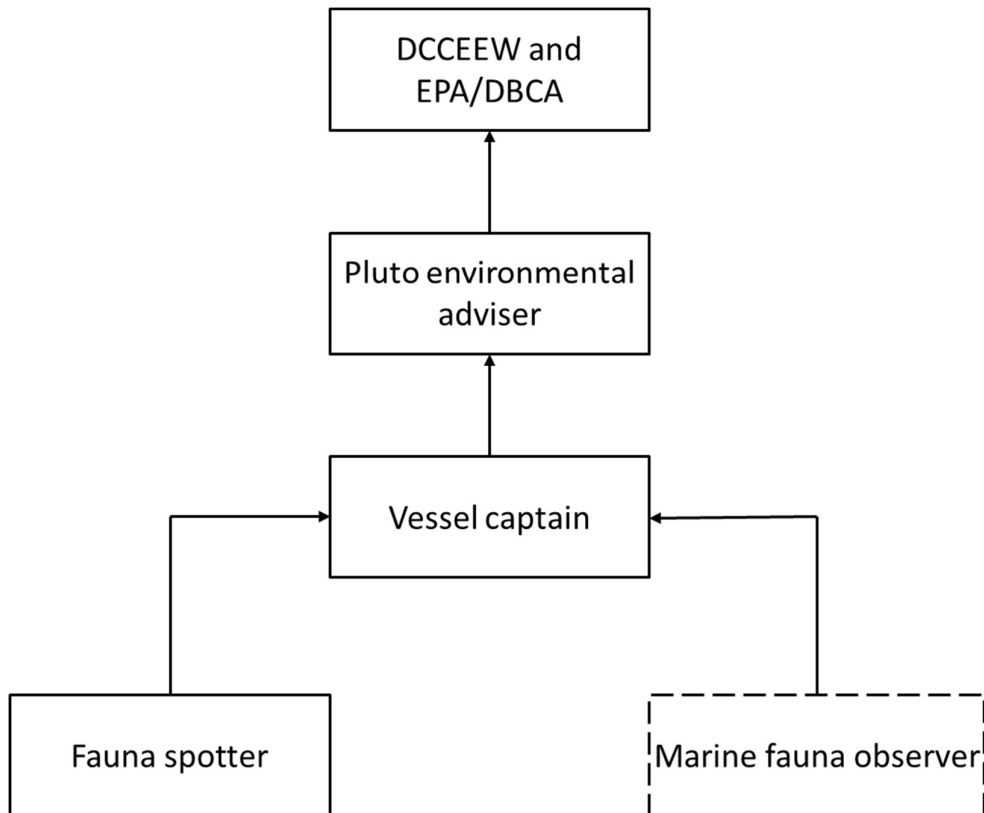
Figure 12 shows the reporting structure during maintenance dredging.

Figure 12 - Recommended Reporting Line for Outcomes of the Turtle Monitoring Program during Maintenance Dredging activities *Note - The MFO is a temporary position and would only be required based on the requirements outlined in Section 4.2.*
