Pluto LNG – Sea Turtle Management Plan

August 2024

Revision 13

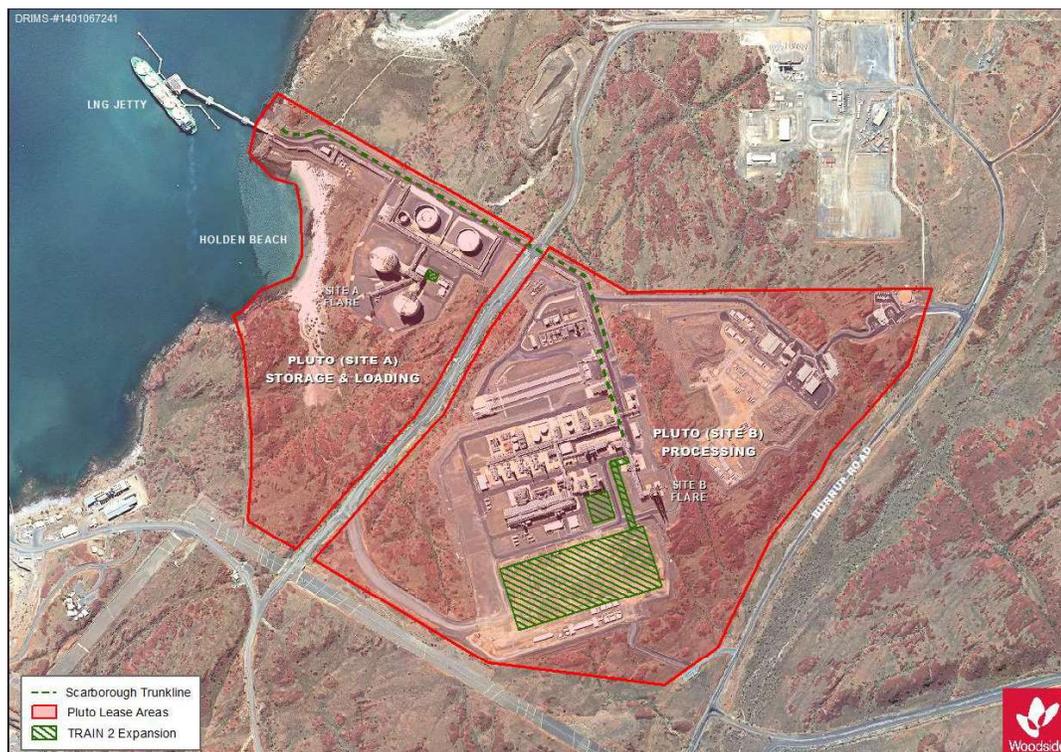
Figure 1 - Pluto LNG Site A and B on the Burrup Peninsula

The onshore and nearshore components of Pluto Foundation and the proposed Pluto Expansion are shown within **Figure 1**.

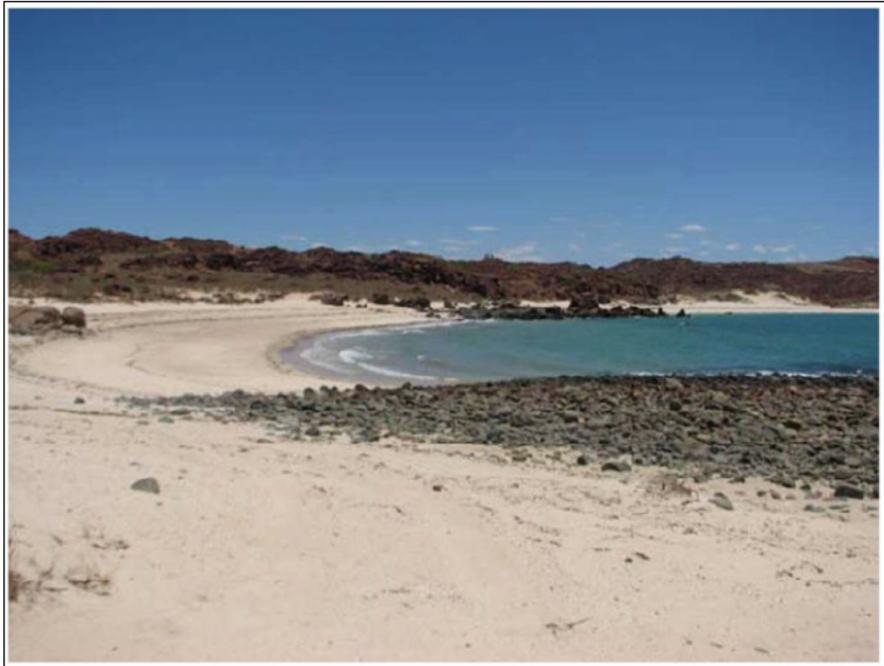
Figure 3 - Image of Holden Beach at low tide

Holden Beach is a north-west facing beach, approximately 590 m in length, situated immediately south of the existing Pluto LNG jetty, on the western coast of the Burrup Peninsula. The beach is split into two beaches by a rocky outcrop, which extends into the intertidal zone (**Figure 3**).

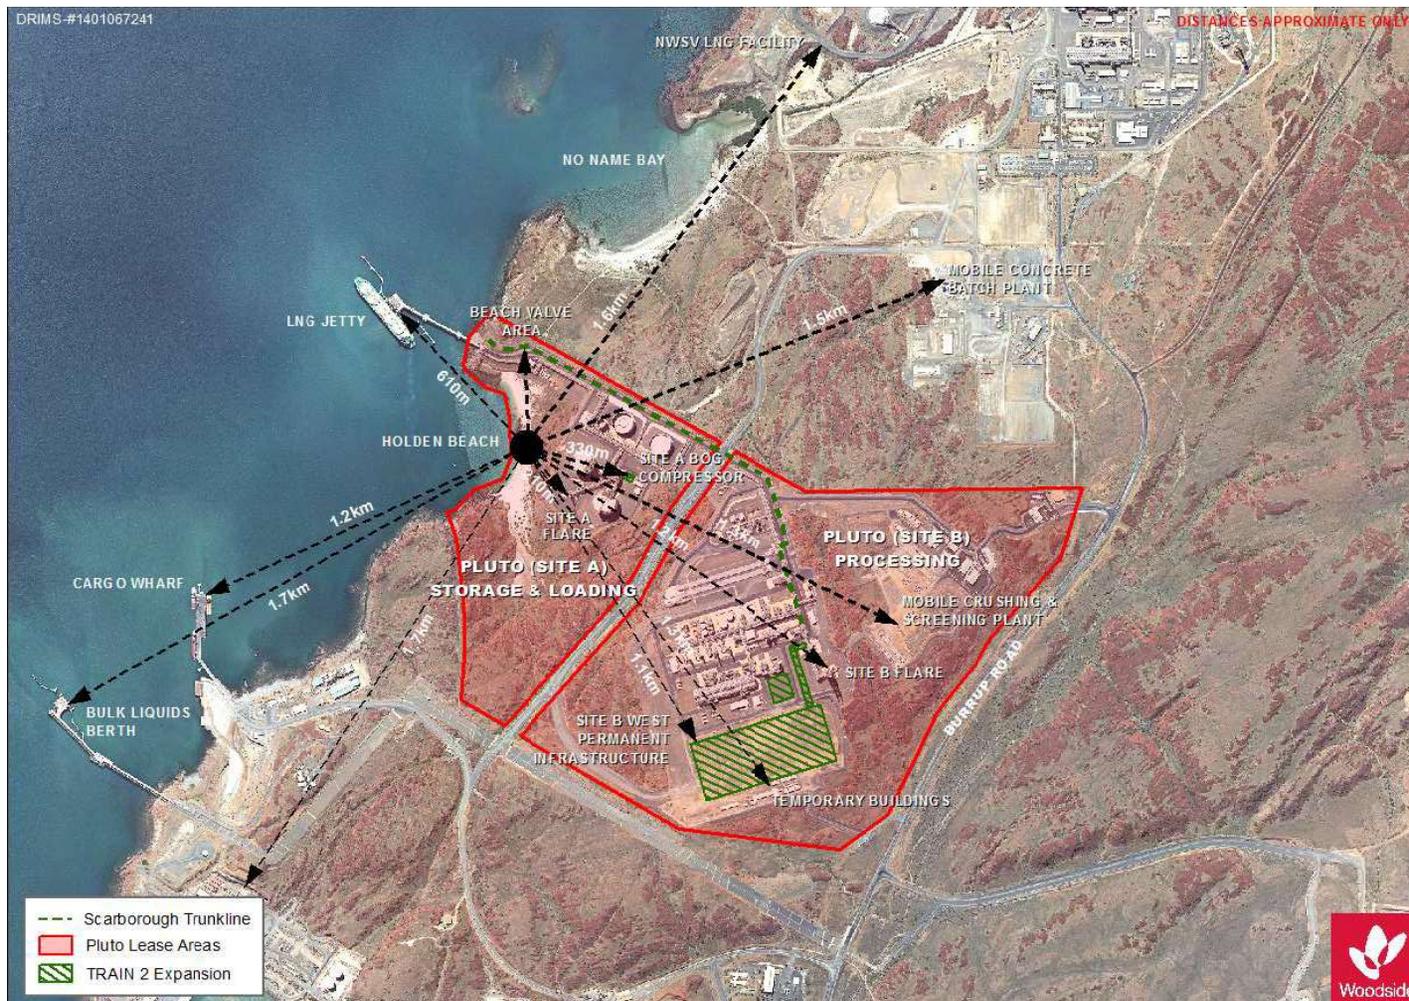
Figure 4 - Existing and proposed lighting sources within close proximity to Holden Beach

Infrastructure	Distance/ Direction from Holden Beach	Lighting observed from Holden Beach
Pluto LNG Jetty	Adjacent to Holden Beach	Direct line of sight
Pluto LNG Storage and Loading Flare (Site A)	0.21 km east	Direct line of sight
Pluto LNG Site A infrastructure	Adjacent to Holden Beach	Light overspill/glow
Pluto LNG Flare stack (Site B)	1.18 km east	Light overspill/glow
Dampier Cargo Wharf	1.1 km south	Direct line of sight
Bulk Liquids Berth	1.7 km south	Direct line of sight
NWSV LNG Facility	1.6 km north	Direct line of sight
Dampier Port Authority- Cargo Wharf Administration Building	1 km south	Light overspill/glow
King Bay Supply Base	1.8 km south	Light overspill/glow
LNG Tankers/ Vessels (Transient)	Not applicable	Light overspill/glow
