Pluto LNG – Sea Turtle Management Plan

August 2023

Revision 12

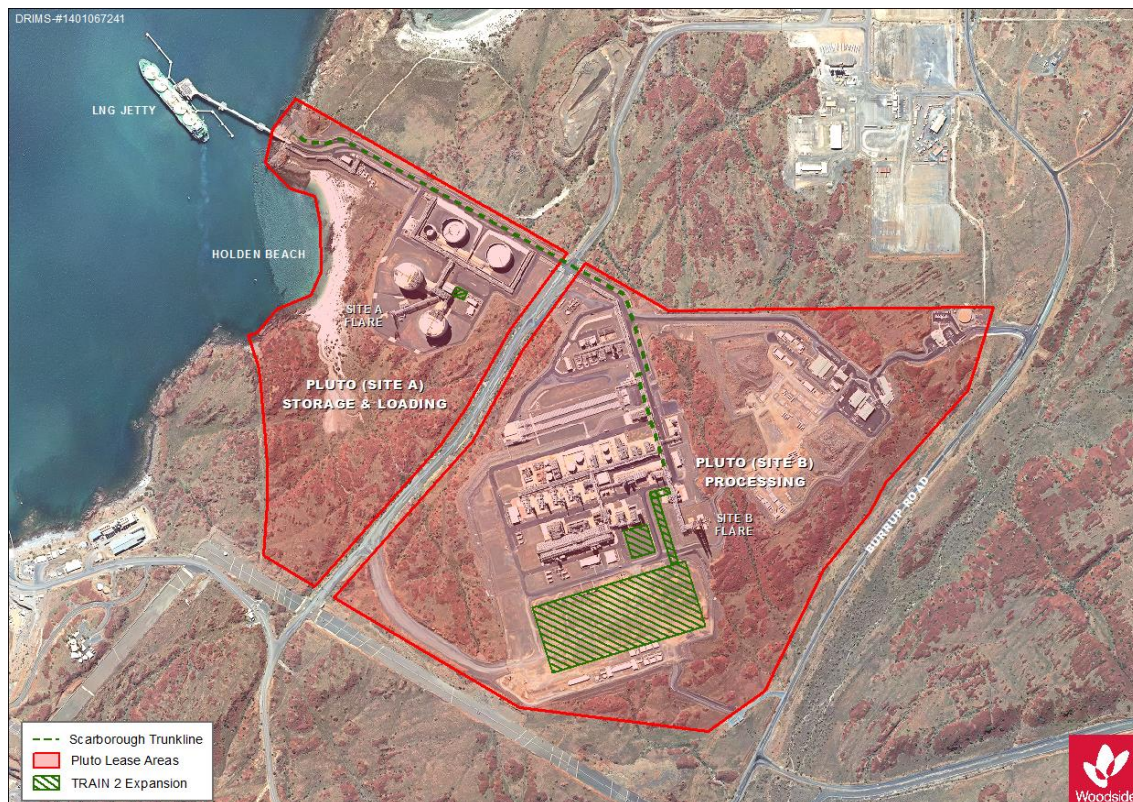
The onshore and nearshore components of Pluto Foundation and the proposed Pluto Expansion are shown within **Figure 1**.

Figure 1 - Pluto LNG Site A and B on the Burrup Peninsula

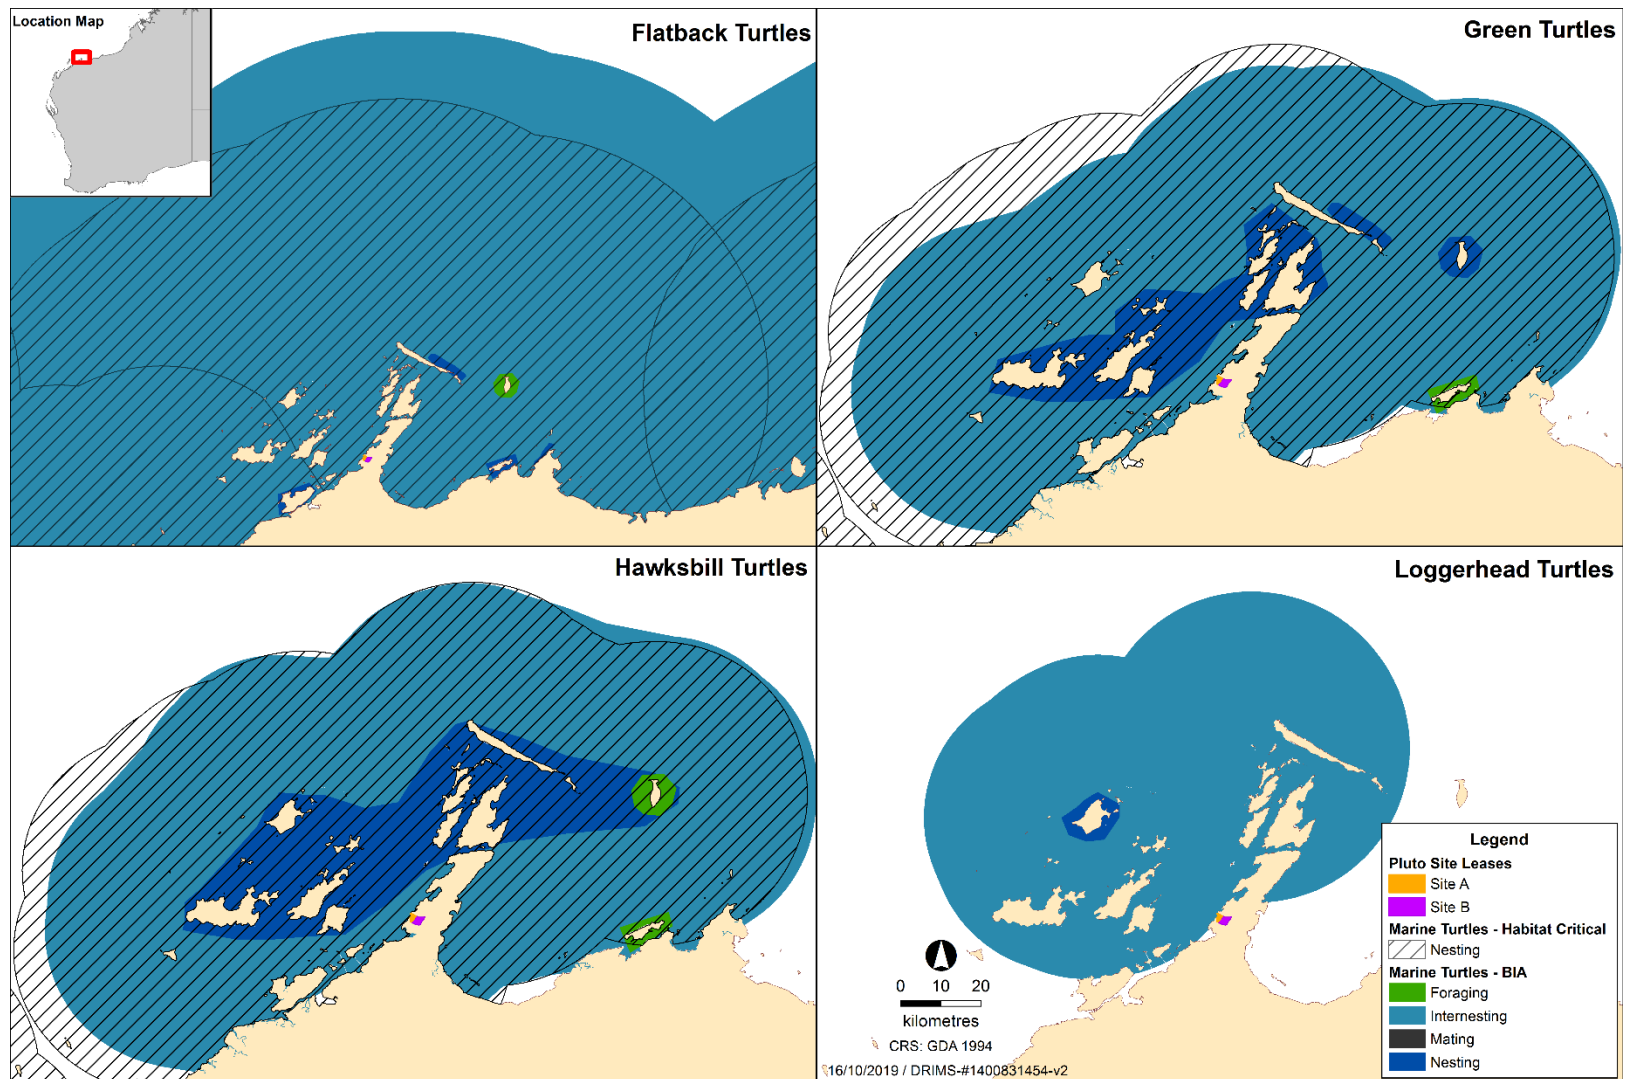
Figure 2 – Habitat Critical and BIAs for Sea Turtle Species within the Dampier Archipelago (DoEE, 2017)

Post-nesting migratory routes for green, hawksbill and flatback turtles were recorded for the Northwest Marine Region (from Barrow Island and mainland sites) (Chevron Australia Pty Ltd, 2015). Green, flatback and hawksbill turtles travelling from nesting sites to foraging grounds generally travelled east or south of Barrow Island and around or through the Dampier Archipelago and along the coast towards foraging grounds to the north (north of Broome). The hawksbill turtle was an exception as it tended to travel south to the coastal island chain south of Barrow Island (Chevron Australia Pty Ltd, 2015). As shown in **Figure 2**, there is a defined foraging BIA for green and hawksbill turtles around Dixon Island.

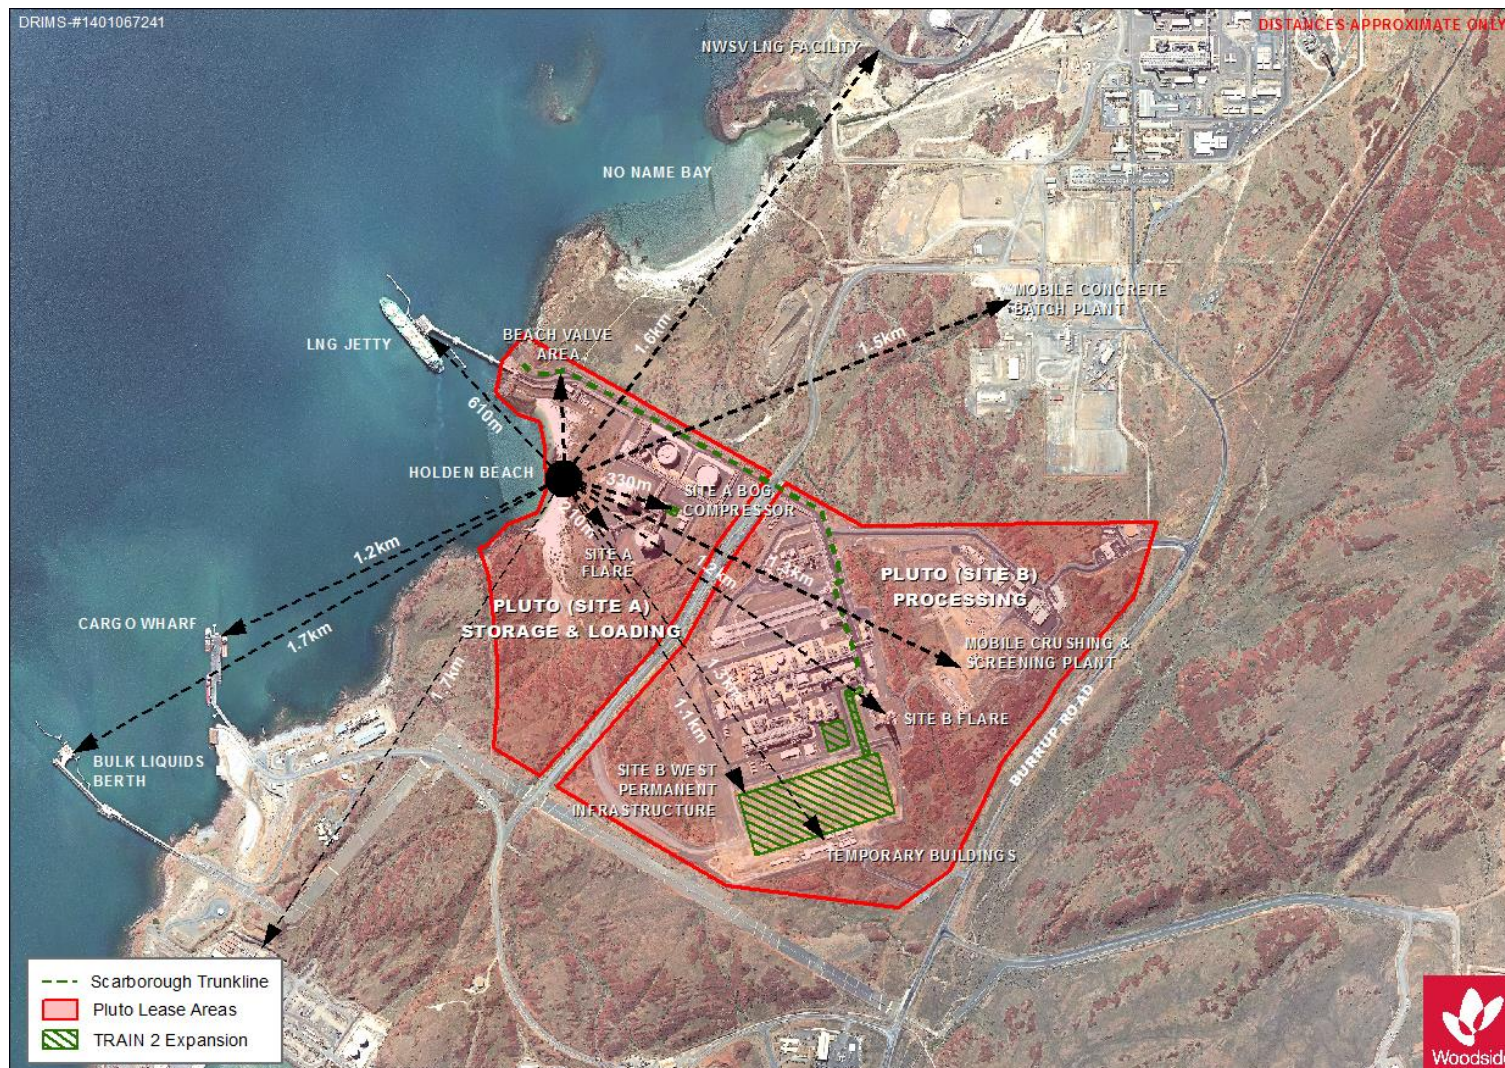
Figure 4 - Existing and proposed lighting sources within close proximity to Holden Beach

Infrastructure	Distance/ Direction from Holden Beach	Lighting observed from Holden Beach
Pluto LNG Jetty	Adjacent to Holden Beach	Direct line of sight
Pluto LNG Storage and Loading Flare (Site A)	0.21 km east	Direct line of sight
Pluto LNG Site A infrastructure	Adjacent to Holden Beach	Light overspill/glow
Pluto LNG Flare stack (Site B)	1.18 km east	Light overspill/glow
Dampier Cargo Wharf	1.1 km south	Direct line of sight
Bulk Liquids Berth	1.7 km south	Direct line of sight
NWSV LNG Facility	1.6 km north	Direct line of sight
Dampier Port Authority- Cargo Wharf Administration Building	1 km south	Light overspill/glow
King Bay Supply Base	1.8 km south	Light overspill/glow
LNG Tankers/ Vessels (Transient)	Not applicable	Light overspill/glow

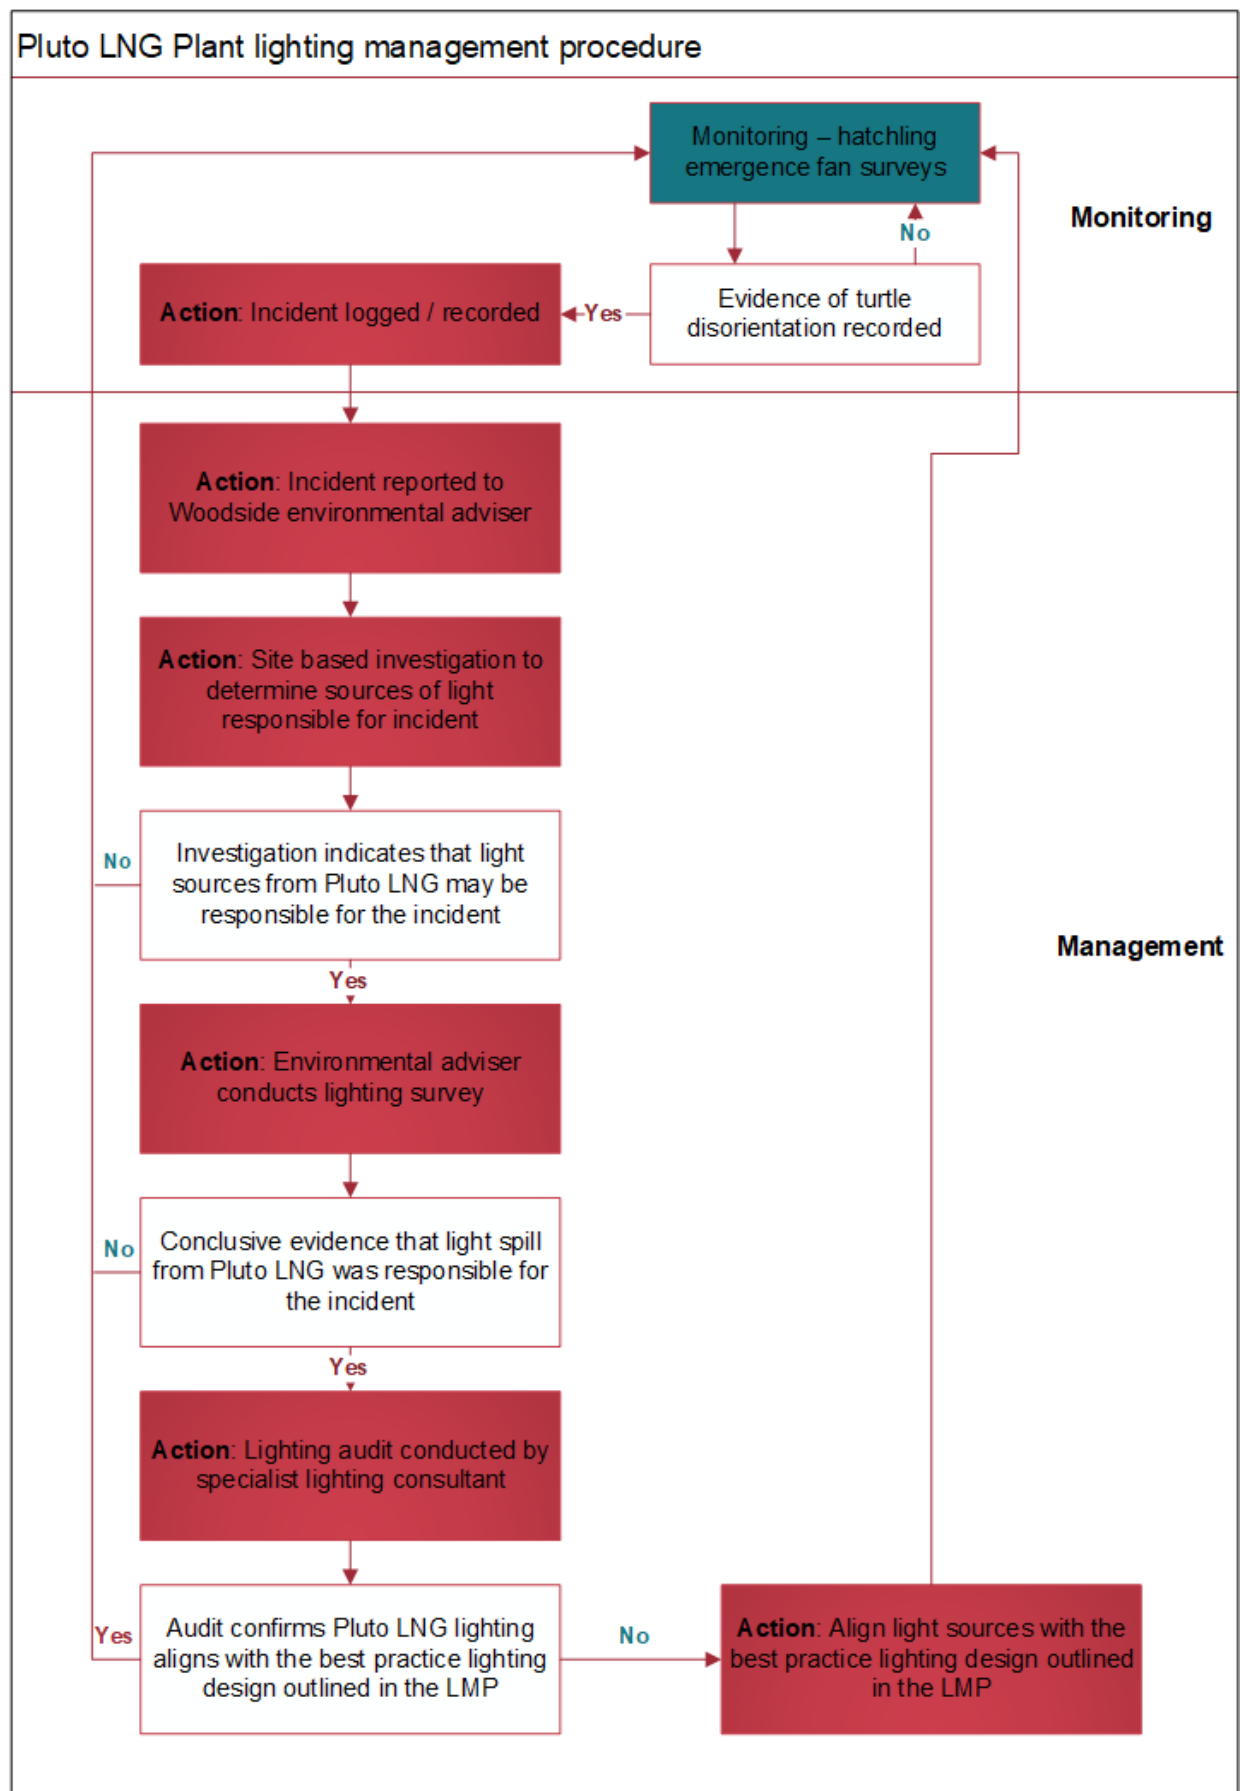
Figure 6 – Pluto LNG lighting management procedure

Table 13 and **Table 14** summarise the subsequent actions that will be implemented if evidence of turtle disorientation resulting from onshore lighting from Pluto LNG (Foundation or Expansion) is recorded. The adaptive management framework that would apply for both operational and construction phases of the project is shown in **Figure 6**.

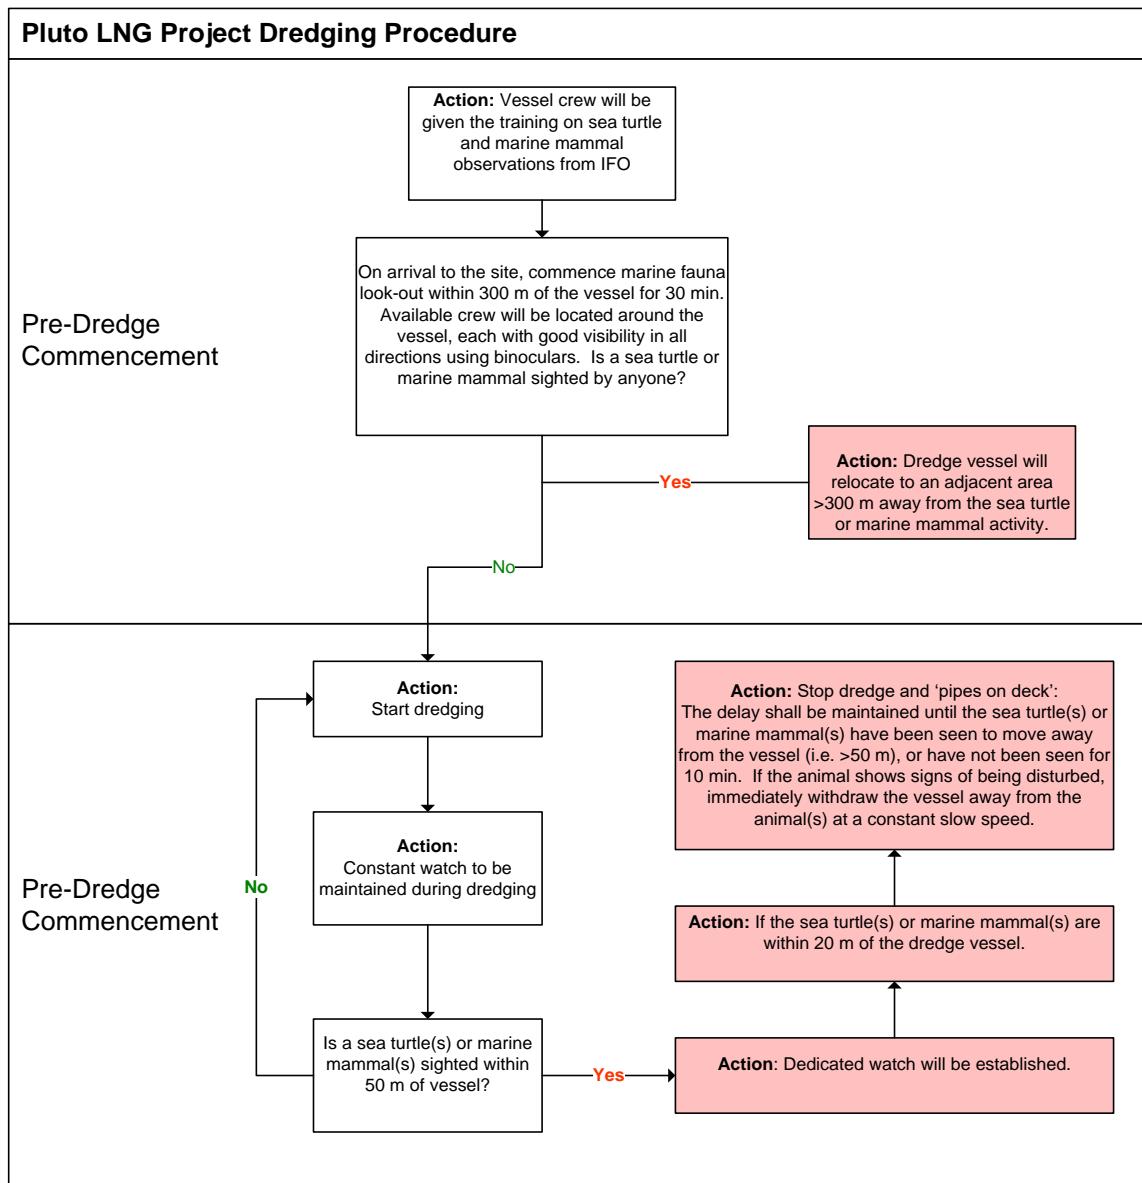
Figure 7 - Maintenance Dredging Procedure

In advance of future maintenance dredging activities (related to Pluto Foundation), the dredge vessel crew will receive training from a qualified marine fauna observer (MFO). In the absence of a MFO, the vessel captain will be responsible for logging sighting and sea turtle injury/death reporting by the crew. These procedures must be followed as part of any maintenance dredging (**Figure 7**) and spoil disposal (**Figure 8**) procedure.

It is noted that the dredging procedure (**Figure 7**) identifies a 20 m exclusion zone to be maintained for sea turtles and marine mammals in the event that animals are identified within 50 m of the vessel. Application of the 20 m exclusion zone with respect to dolphins is not considered feasible. Dolphins are unique in that they:

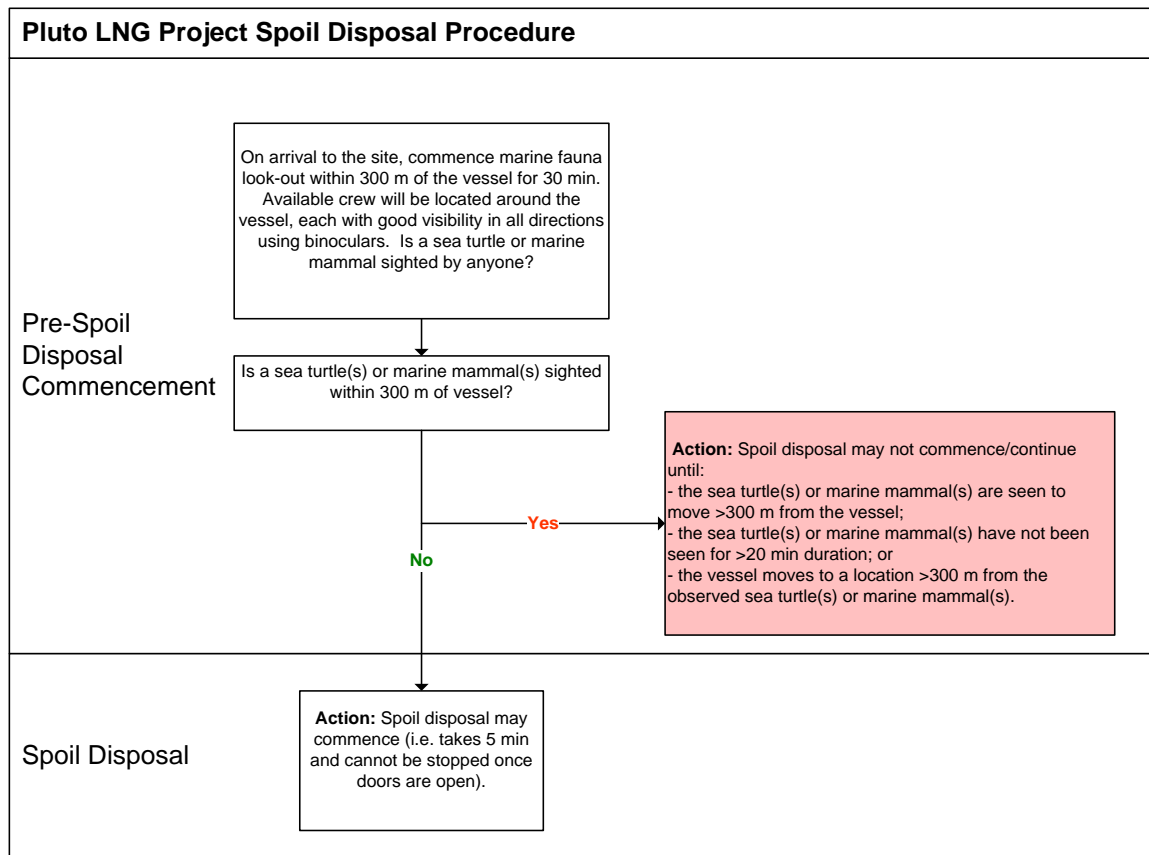
Figure 8 - Dredge Spoil Disposal Procedure

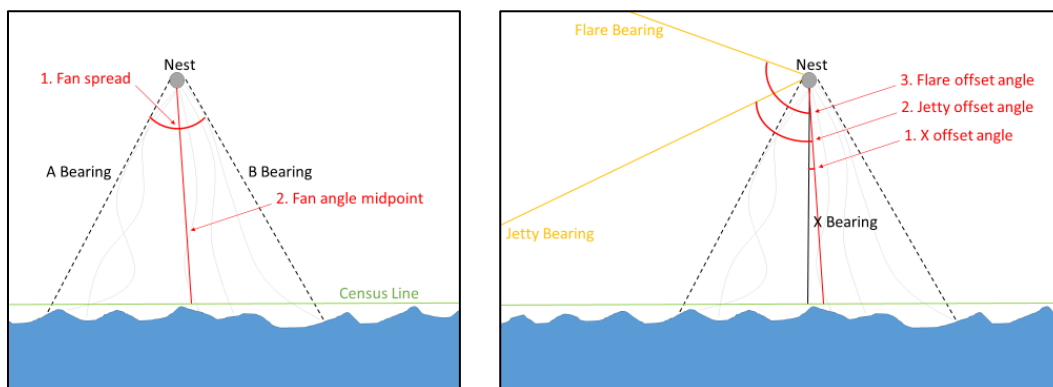
- Fan spread, which is the angle between A-B Bearings.
- Fan angle midpoint, which is the midpoint between A-B Bearings.
- Offset Angles, which are the angles between the fan angle midpoint and
 1. the X Bearing (X offset angle);
 2. the Jetty Bearing (Jetty offset angle); and
 3. the Flare Bearing (Flare offset angle).

Figure 9 - Illustration of fan spread and offset angle parameters for hatchling emergence fan survey

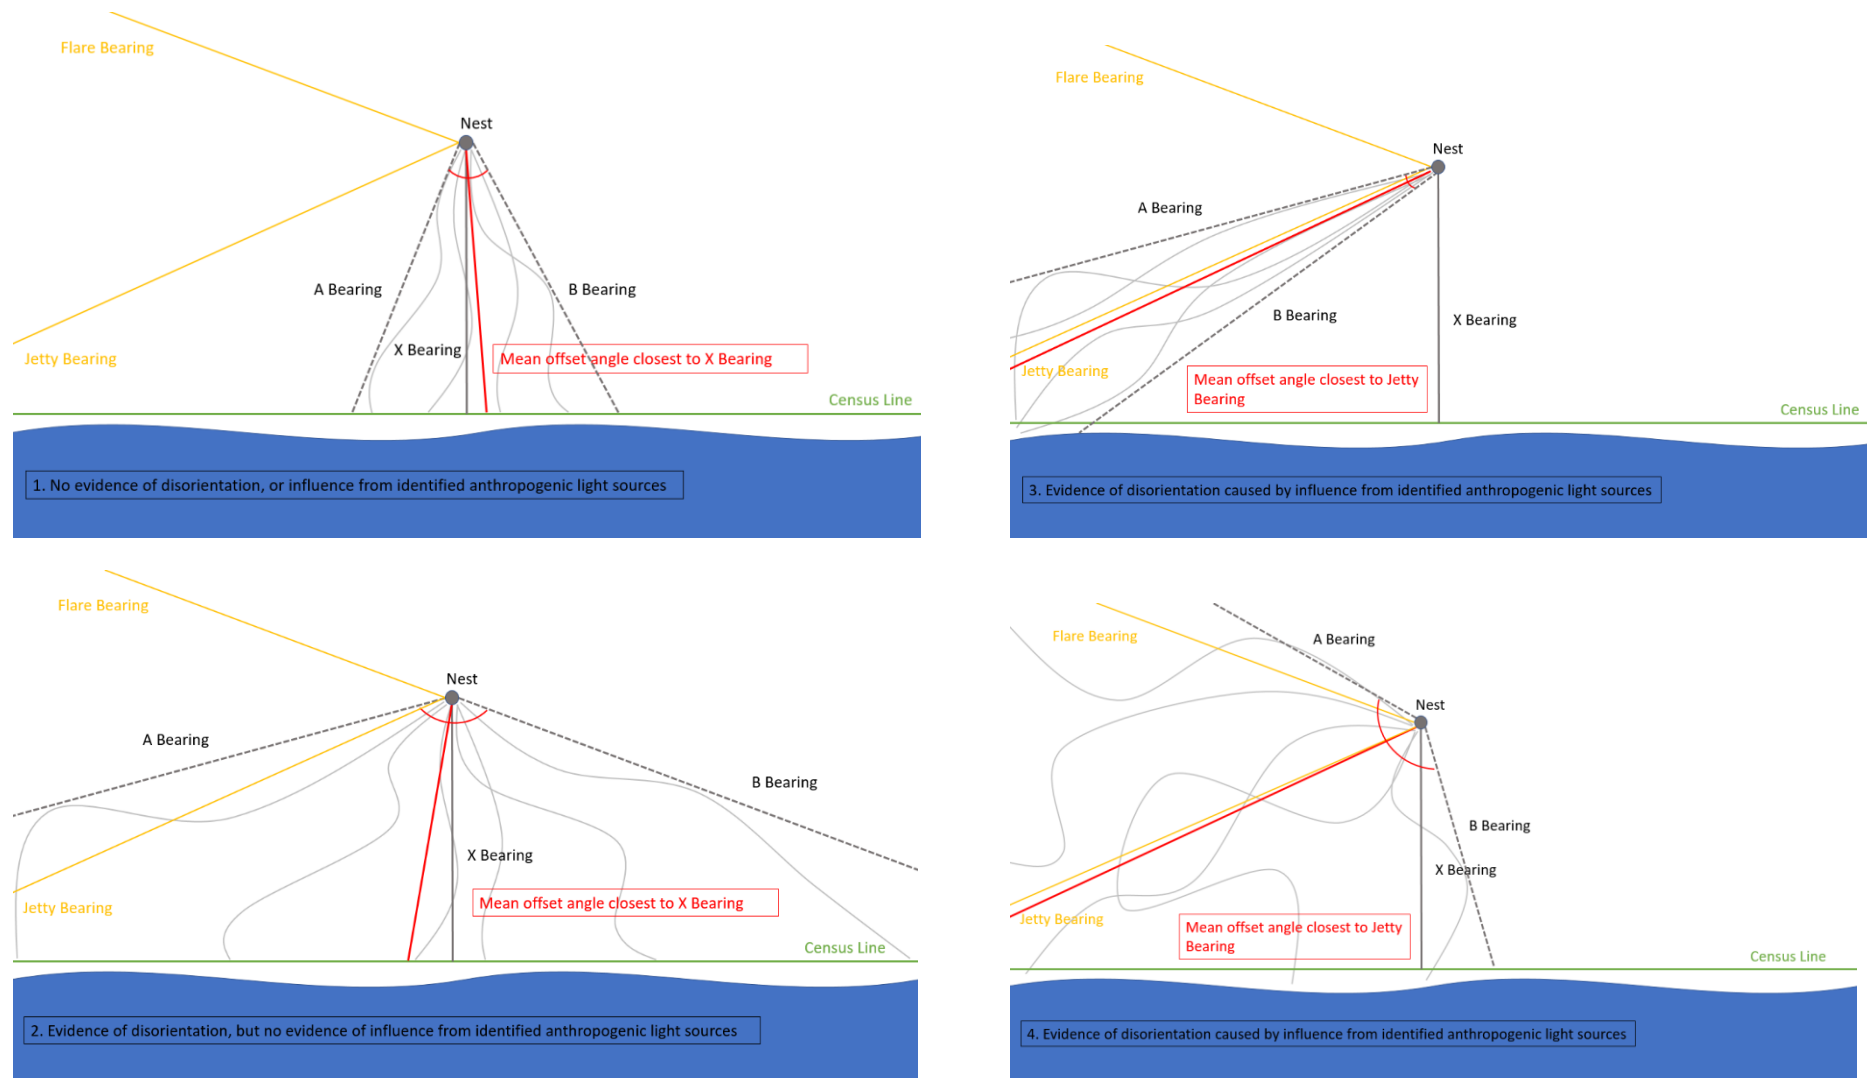
Figure 10 outlines the main scenarios that may occur from the described hatchling emergence fan surveys: the top-left illustrates a scenario where there is no evidence of disorientation or influence from anthropogenic sources; the bottom-left figure illustrates evidence of disorientation, however, with no apparent influence from the identified anthropogenic light sources; the top and bottom figures on the right show influence from the jetty anthropogenic light source, with both small and large fan spread angles. In both these cases, it would be considered that there was an incident or hatchling turtles being disoriented by light associated with Pluto LNG and proceeding actions would be triggered (refer to Performance Management Targets in **Table 13** and **Table 14**).

Figure 10 - Hatchling emergence fan survey decision criteria (top-left: no disorientation or anthropogenic influence; bottom-left: evidence of disorientation, but no anthropogenic influence; top and bottom right: evidence of disorientation caused by anthropogenic influence).

To determine hatchling orientation, the smallest offset angle can be used to infer the most influential navigation aid used by the hatchlings. If the smallest angle is the X offset angle then it can be concluded that there was no significant influence from the identified anthropogenic light sources (as shown in **Figure 10(1)** and **10(2)**). Alternatively, if the smallest angle is either the jetty or the flare offset angles, there is evidence that these light sources are significantly influencing the hatchling's navigation (as shown in **Figure 10(3)** and **10(4)**).
